Murray Creek Rehabilitation Project

2011 Annual Report

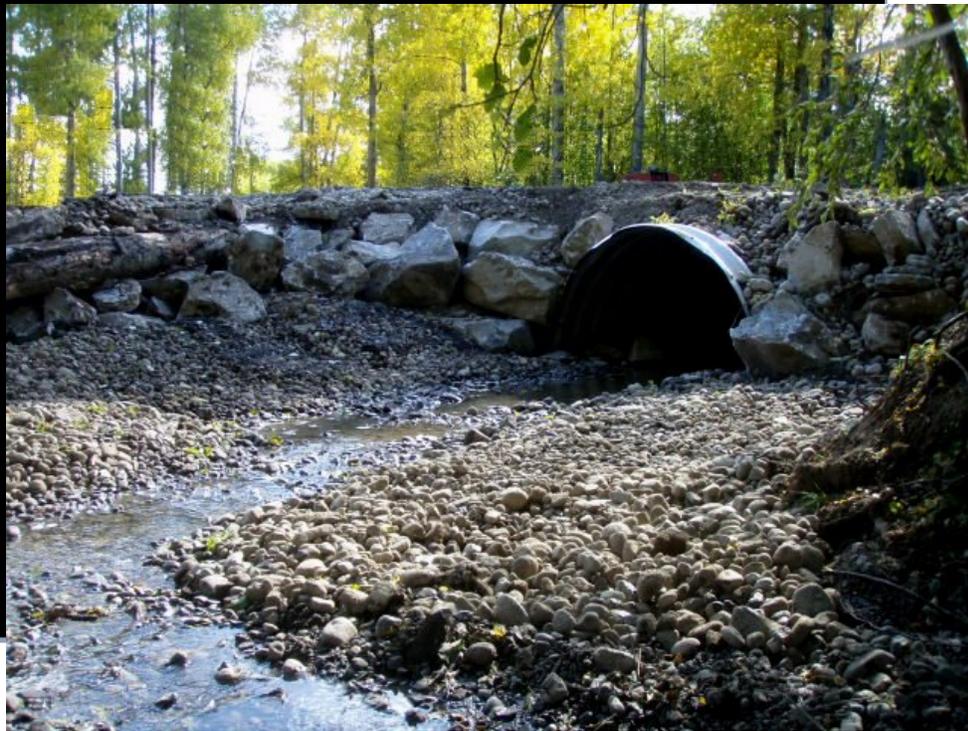
Project Number: 11-01- Before

General Description and issues: Removal of two undersized and hanging closed bottom culverts and construction of cobble/gravel based crossing using geo-grid.

Before: One of two undersized and hanging culverts to be removed.

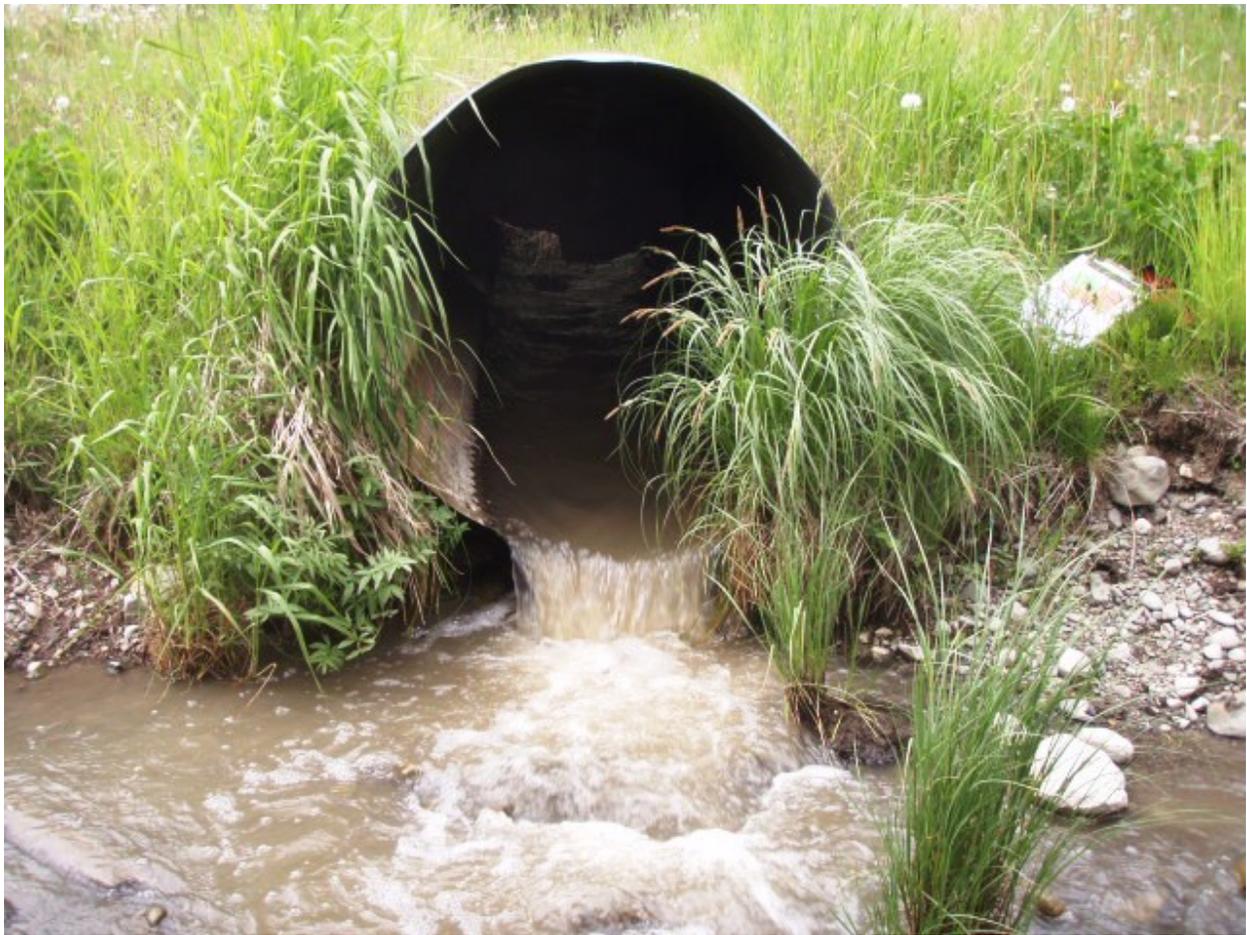
Project Number: 11-01- after

After: Two undersized and hanging culverts removed and a drain rock/cobble crossing constructed.

Outcomes: Two undersized and hanging closed bottom culverts removed, and a cobble/gravel based crossing completed successfully. Approximately 300m of stream upstream of culvert is now accessible to fish.

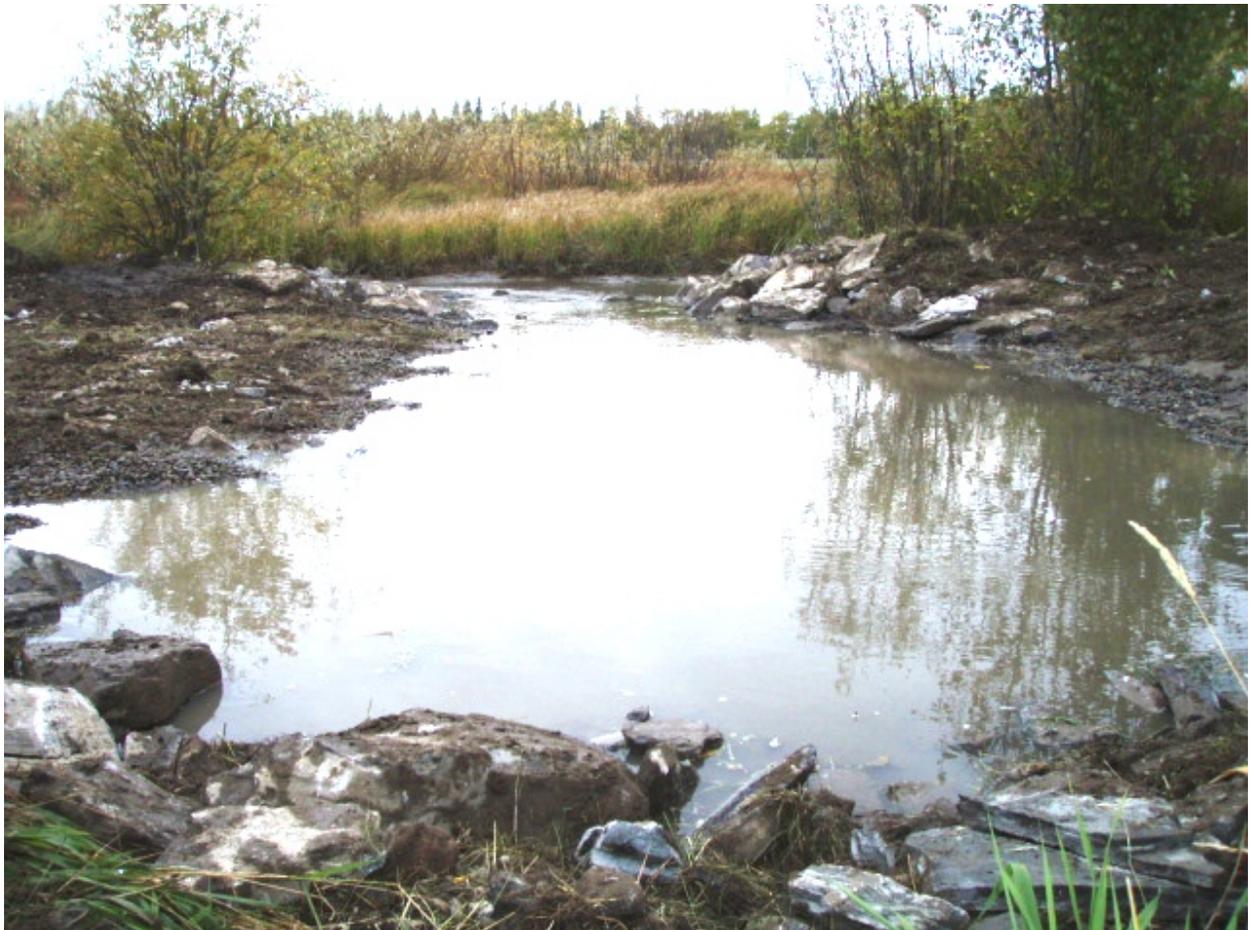
Project Number: 11-02 - Before

General Description and issues: Removal of one undersized closed bottom culvert and construction of streambed prior to installation of an 1828mm Span x 914mm Rise m open bottom culvert.

Before: One undersized culvert to be removed

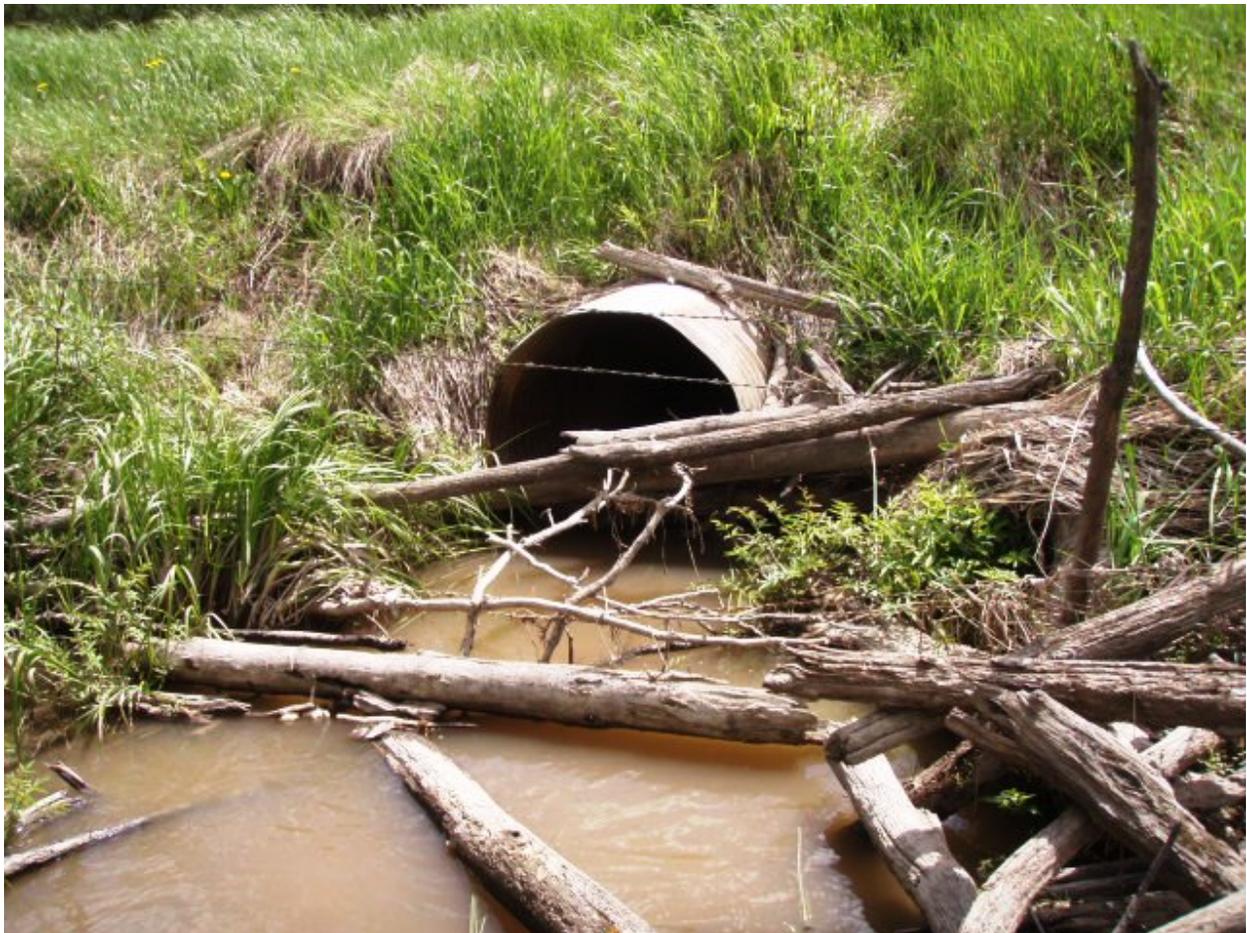
Project Number: 11-02- After

After: Installation of an 1828mm Span x 914mm Rise m open bottom culvert.

Outcomes: Removal of an undersized closed bottom culvert and installation of an 1828mm Span x 914mm Rise m open bottom culvert. Approximately 800m of stream upstream of culvert is now accessible to fish.

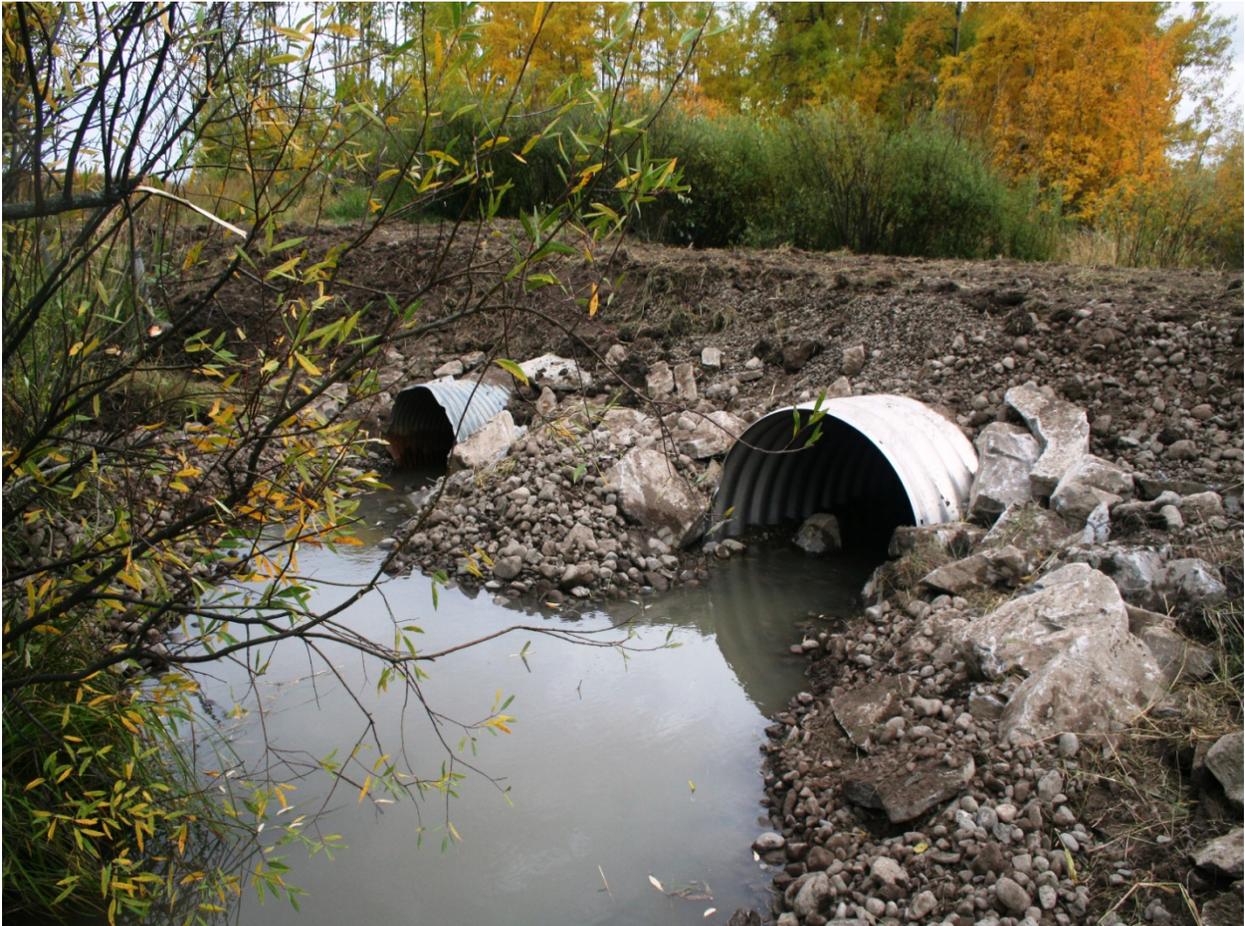
Project Number: 11-03- Before

General Description and issues: A combination of grazing activity, fine glacial-lacustrine bank material and the blowout of a beaver dam have contributed to lateral stream movement and erosion of the stream bank in several places. The prescription included strategically placing rock armoring on the stream bank for increased structural integrity, and the planting of native (willow) and grass species, to prevent further erosion and sediment distribution downstream.

Before: Undercutting of stream banks & extensive cattle use eroding stream banks.

Future needs: Stream should be fenced to keep cattle away from stream banks.

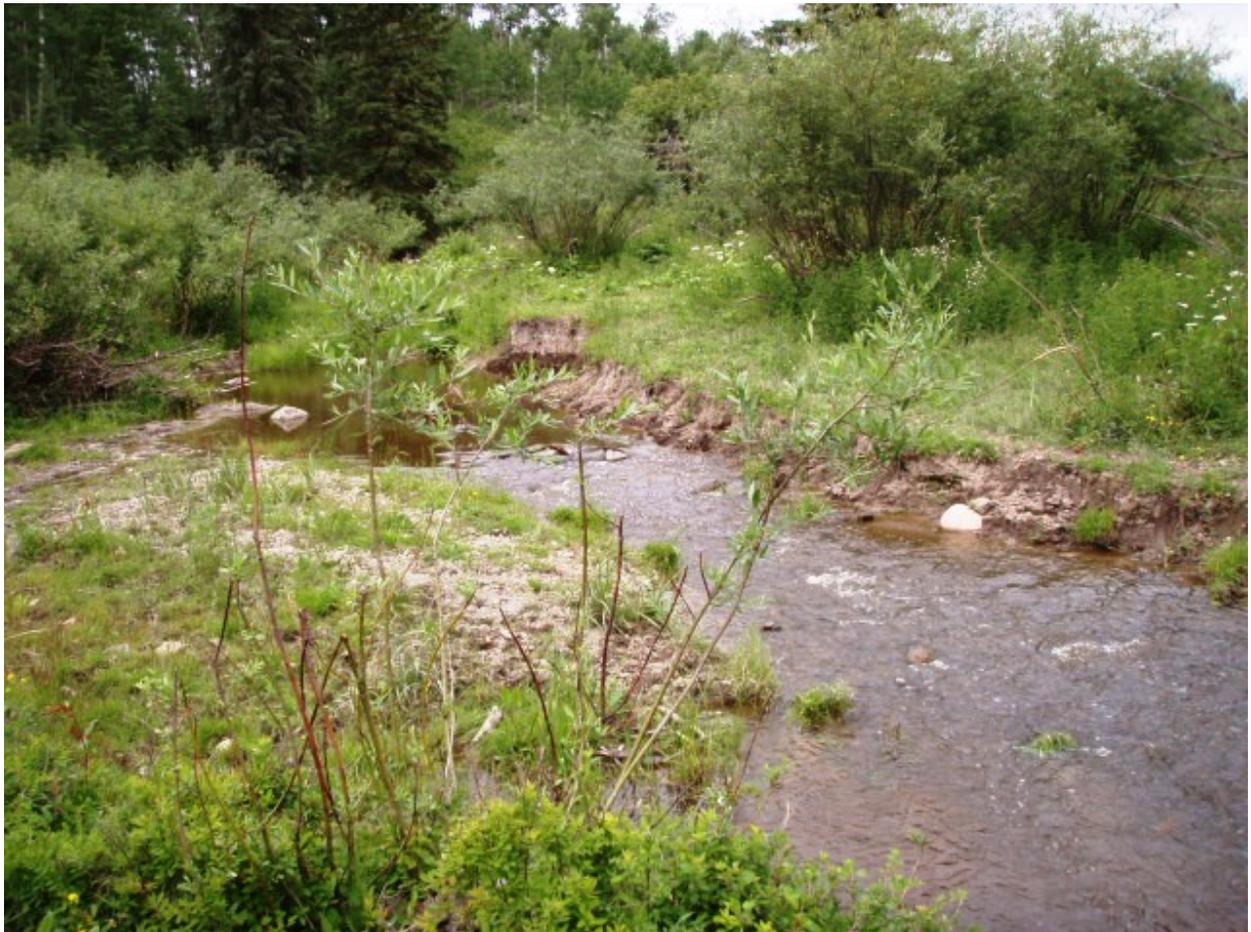
Project Number: 11-03- after

After: Set back armoring riprap construction of stream banks in problem areas.

Outcomes: Approximately 110m of stream bank was armored and stabilized preventing further erosion and sediment deposition.

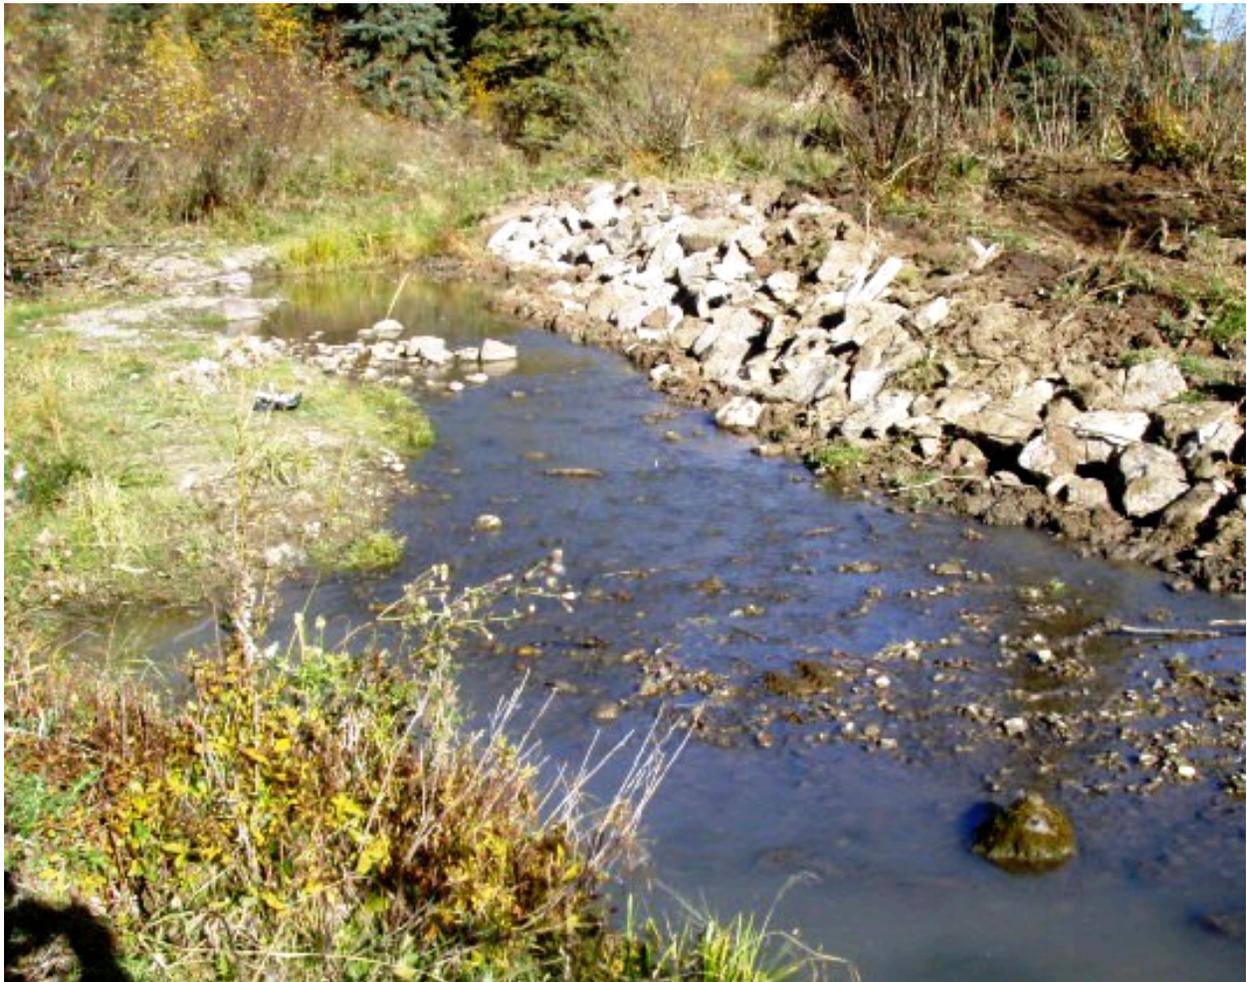
Project Number: 11-04 - Before

General Description and issues: Removal of three undersized closed bottom culverts and construction of streambed prior to installation of a 2438mm Span x 1219mm Rise Dur-A-Span Arch

Before: Three culverts in various stages of erosion were removed

Future needs: Fencing off of Murray Creek scheduled for December 2011. Additional deciduous cuttings and conifers will need to be planted.

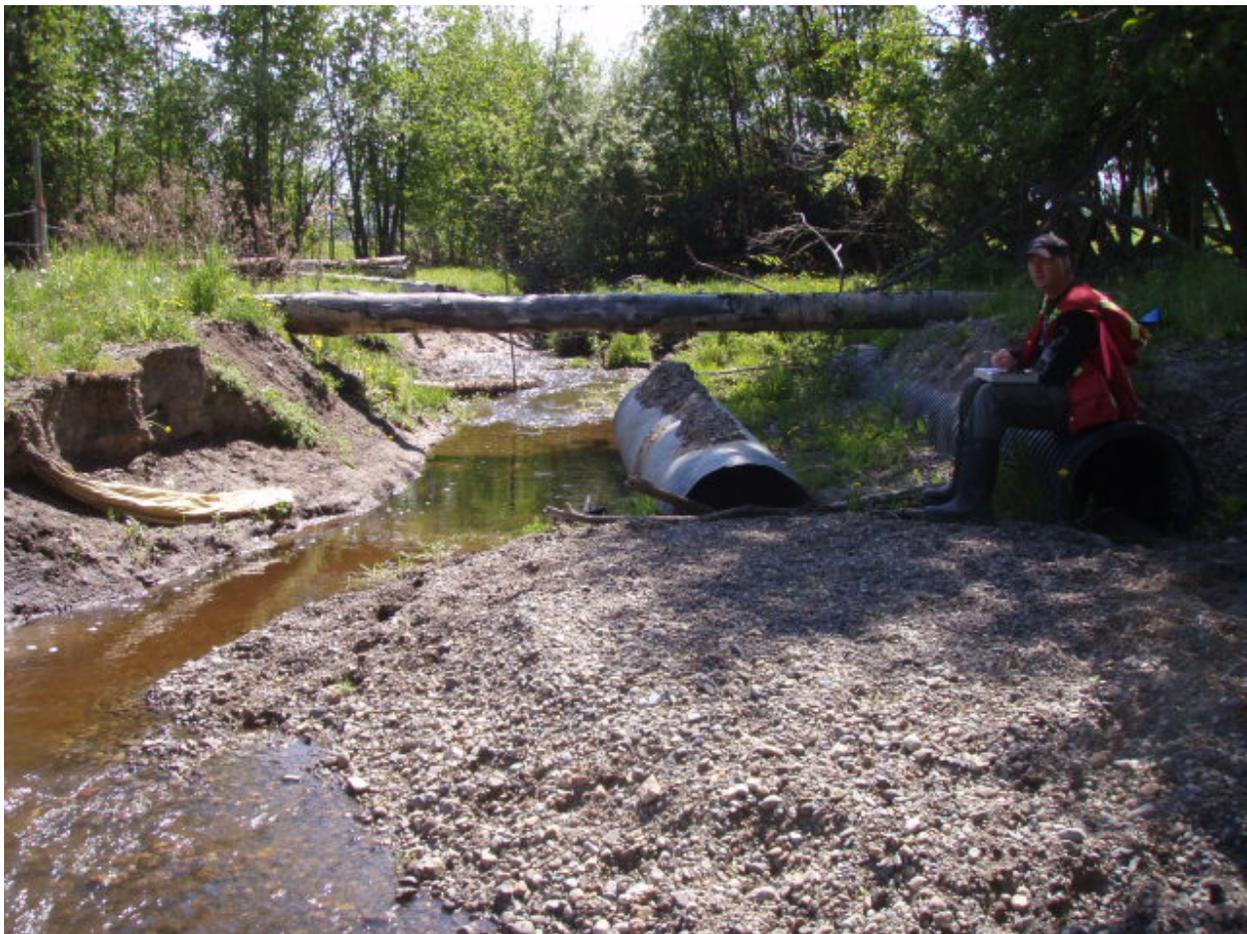
Project Number: 11-04 - after

After: Arch culvert installed and erosions from cattle and banks were rocked to repair erosions above and below this new installation.

Outcomes: 3 undersized culverts removed, and installation of a 2438mm Span x 1219mm Rise Dur-A-Span Arch. Approximately 650m of stream upstream of culvert is now accessible to fish.

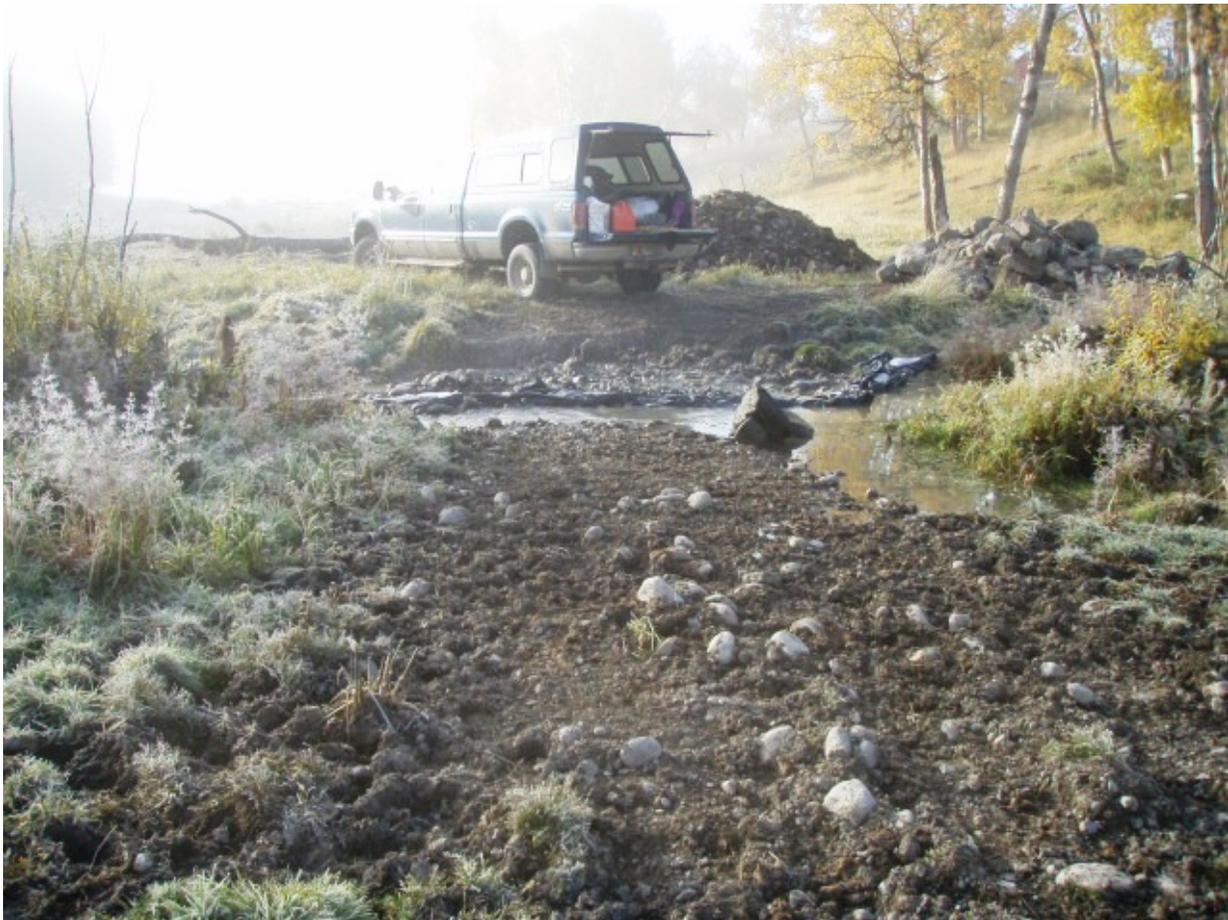
Project Number: 11-05 - after

After: The Murray Creek crossing on Kevin Bailey's property post-work.

Outcomes: Crossing upgrade completed successfully, permitting the reduction of erosion and sediment deposition from unfettered livestock access to the stream.

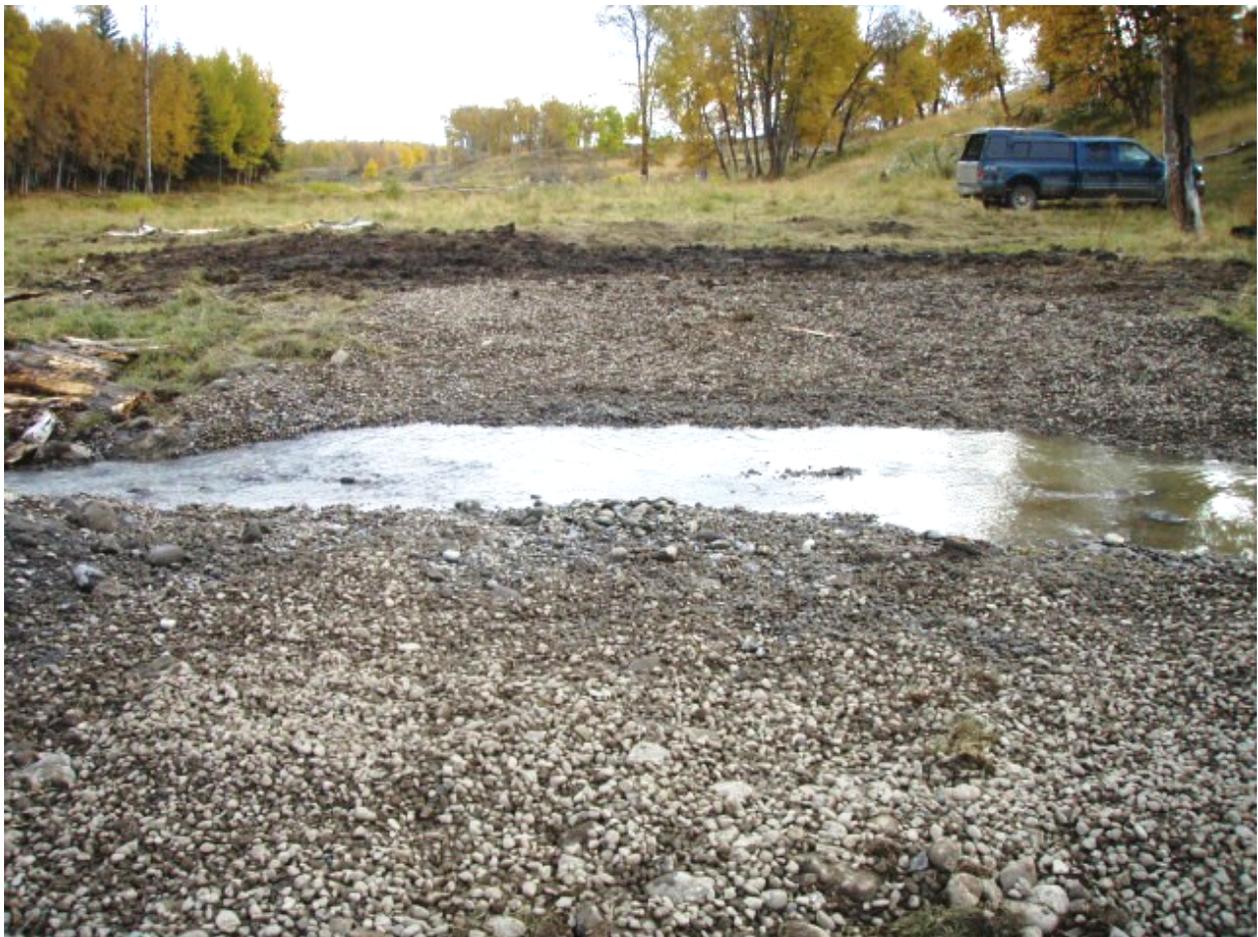
Project Number: 11-06- Before

General Description and issues: An existing crossing was in poor condition. A prescription to upgrade and construct a cobble/gravel based crossing provided a hardened watering site for livestock to drink and cross at the stream.

Before: An existing crossing used by livestock that is contributing sediments into the stream.

Future needs: This section of stream should be fenced except at the crossing and more willow staking would help stabilize stream banks.

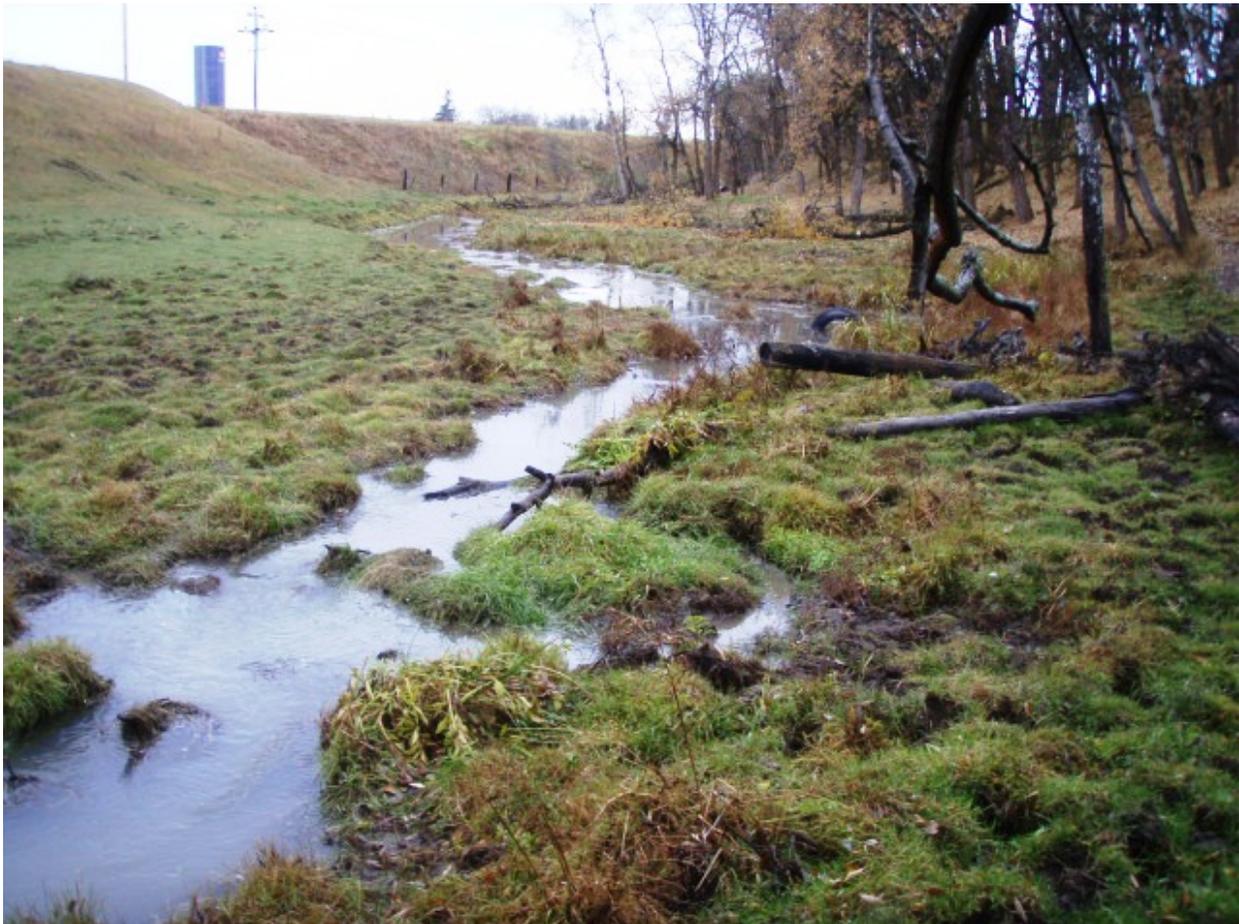
Project Number: 11-06 - after

After: Hardened crossing of drain rock and cobble.

Outcomes: Crossing upgrade completed successfully, permitting the reduction of erosion and sediment deposition from unfettered livestock access to the stream.
