Project Number: FSWP - 10-1 - Before

Location: Alan Martens - Gravel Pit Rd off Larsen Rd

General Description and issues: Undersized culverts removed and replaced with arch culvert

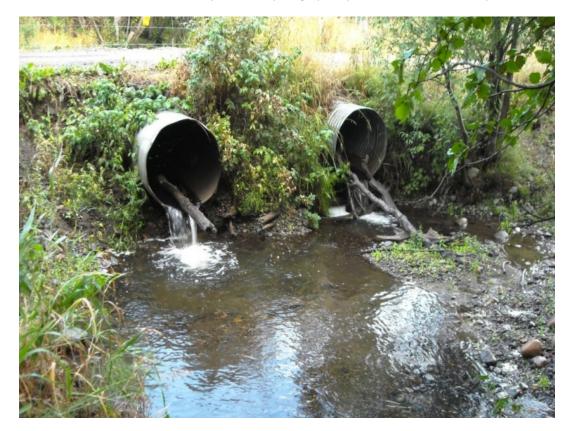
Before: Road washed out for a mile in heavy snow years and then re-entered Murray Creek downstream. Chinook salmon fry found in plunge pool prior to removal and replacement

Future needs: Continue riparian planting above and below installation

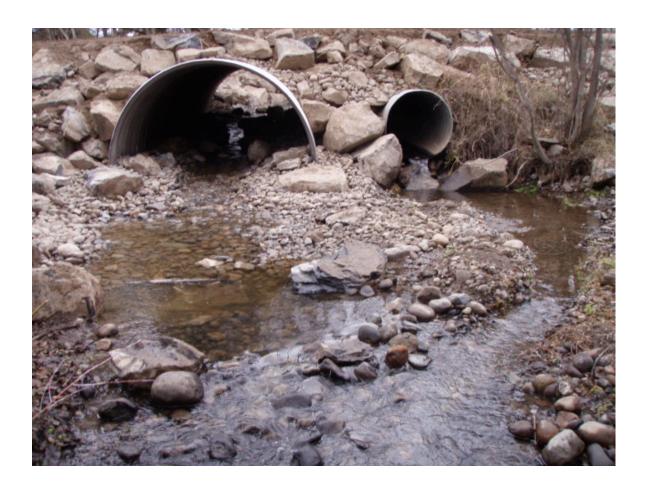
Project Number: FSWP – 10-1- After

Outcomes: Meets flow requirements and provided fish passage and increased stream availability

After: Fry were moving through new culvert within minutes of completion

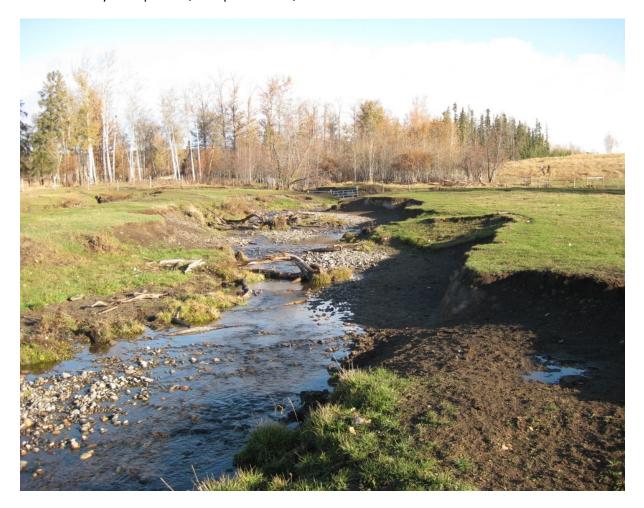
Project Number: HCTF – 10-2 Demo Site - Before

General Description and issues: Decades of heavy use created the situation

Before: Heavily used pasture, no riparian zone, banks have lost structure

Future needs: Continue riparian planting

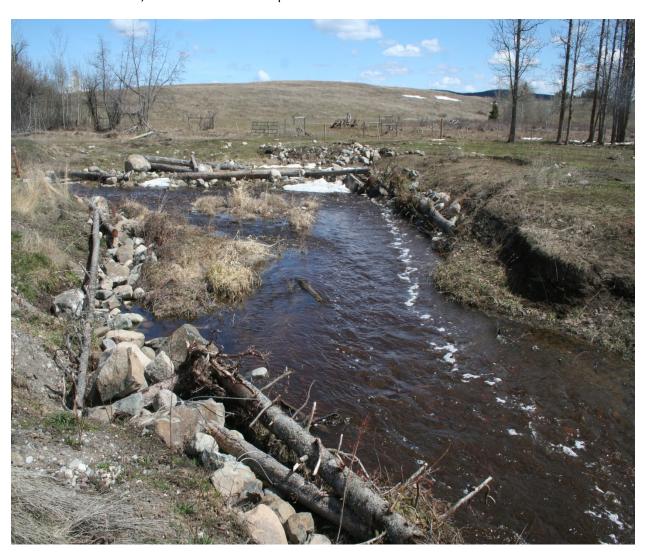
Project Number: HCTF -10-2 Demo Site - After

General Description: Stream started to channelize in the first spring after, area fenced off from cattle

and cattle restricted to one site for watering

After: Banks stabilized, willows and red osier planted

Future needs: Off channel waterier to be installed east of this site

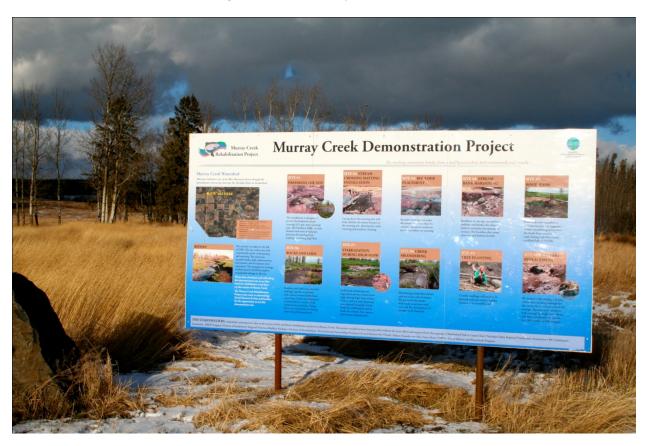
Project Number: HCTF – 10-2 Demo Site

General Description and issues: Decades of heavy use created the situation

Future needs: Continue riparian planting

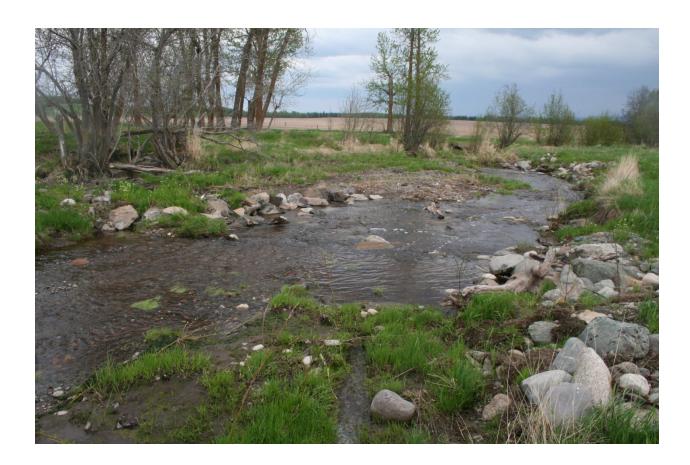
Project Number: HCTF -10-2 Demo Site

General Description: Stream started to channelize in the first spring after, area fenced off from cattle

and cattle restricted to one site for watering

After: Bottom portion of Demo site with banks stabilized, willows and red osier planted

Future needs: Off channel waterier to be installed east of this site

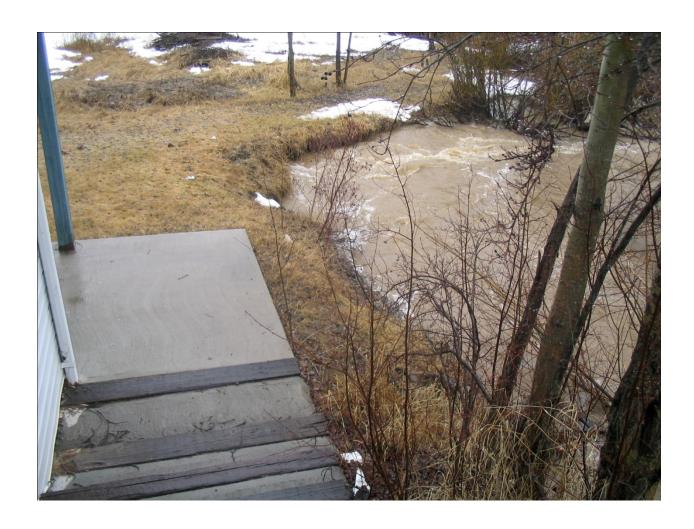
Project Number: FSWP 10-03 - Before

General Description and issues: Narrowing of flood channel upstream increased velocity

Before: Unauthorized work upstream caused stream to start cutting a new channel, jeopardizing foundation of house. This was moving more silt downstream and also increasing stream velocity.

Future needs: Monitoring

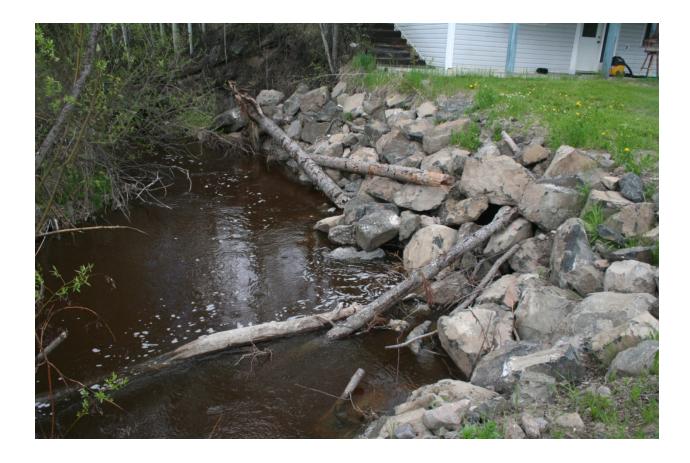
Project Number: FSWP 10-03 - After

After: Rock and log structure installed that allowed stream to meander and continued to utilize old channel.

Future needs: Monitoring

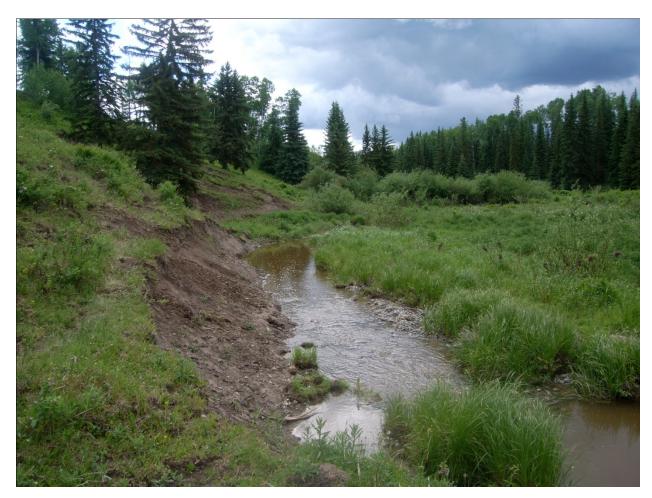
Project Number: FSWP 10-04 - Before

General Description and issues: Banks had lost their structural integrity along with the breakage if a beaver dam years earlier that moved the stream channel against the clay bank and eroded large section of bank downstream

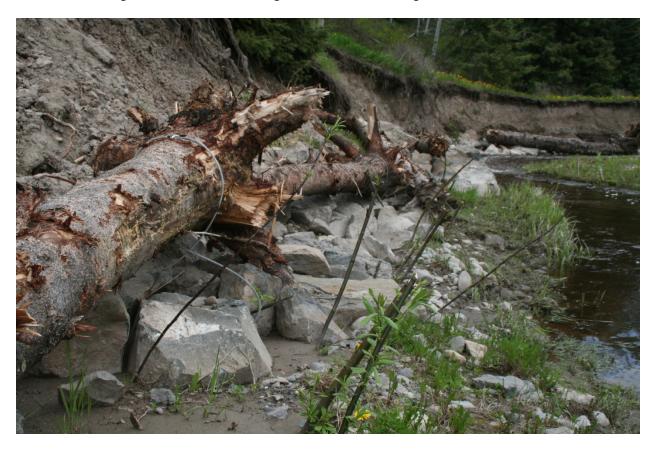
Project Number: FSWP 10-04 -after

After: Rock and log structures installed along with deciduous cuttings that took well.

Future needs: additional planting of willows, alders and conifers. Additional fencing in a couple of spots

will happen

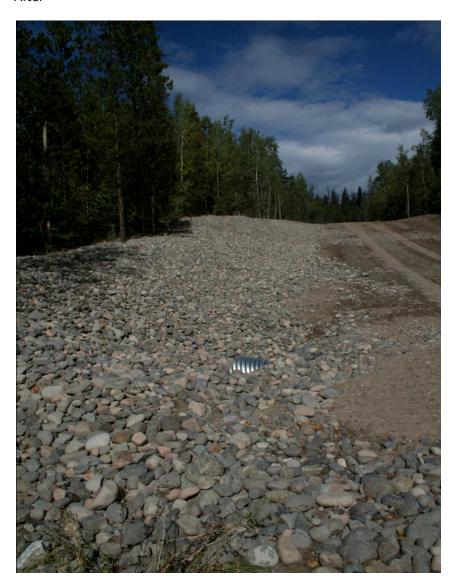
Project Number: 10-05- after

General Description: Silt was moved down the ditch line in heavy rains and was silting Murray Creek up. L&M Lumber had the ditch lined with cobble and installed an additional side culvert that moved this

water into the forested land before entering the stream

Future needs: Monitoring Funder: L&M Lumber Ltd. Donations: \$2500.00

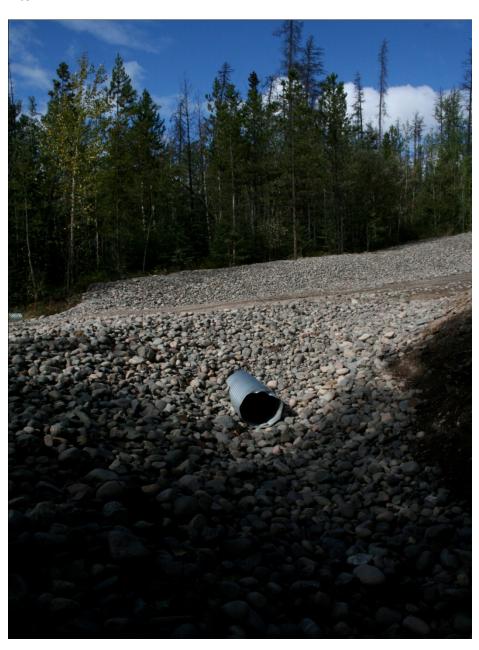
Project Number: 10-05-after

General Description and issues: Silt was washing down ditches of logging road and flowing into Murray

CK.

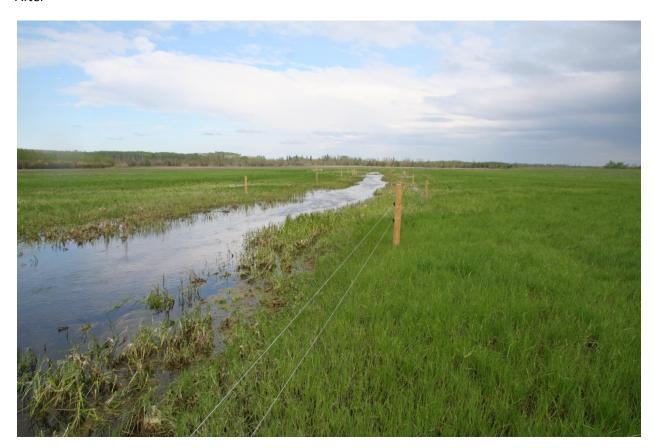
Project Number: 10-06 – Before and after

General Description: David Martens and Sons (DMS)- previous land owner had put the stream "where it belongs" and had farmed through the stream. DMS fenced of the main stream, hardened of four stream crossings for machinery and cattle watering and planted stream sides with willow

Future needs: addition planting of conifers and deciduous species

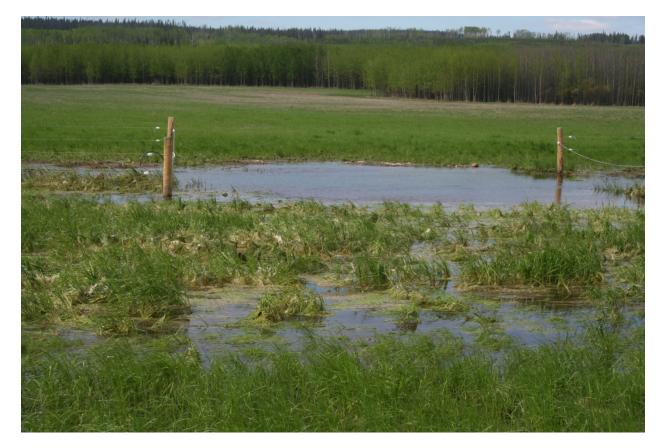
Project Number: 10-06

After; hardened off stream crossing. One of four

Future needs: additional planting of willows, alders and conifers.
