Murray Creek

Culvert Assessment Report

Prepared by: Olin Albertson R.P.Bio.

Submitted: October 11, 2011
Revised: January 8, 2014

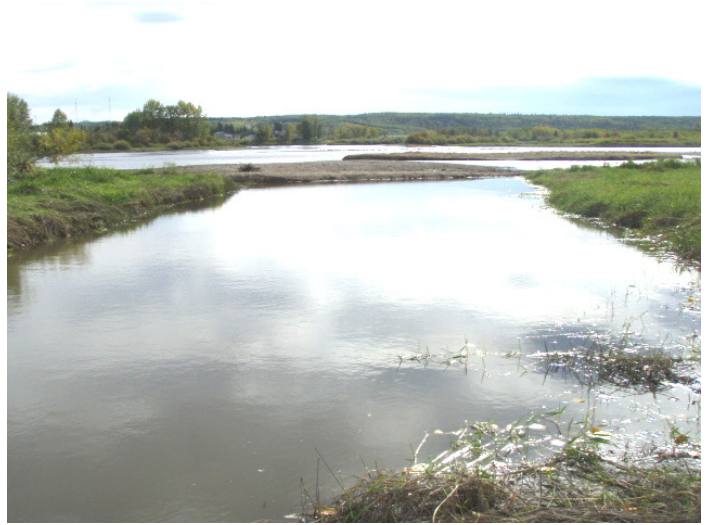
CMP01- Sediment bar from outlet (South)

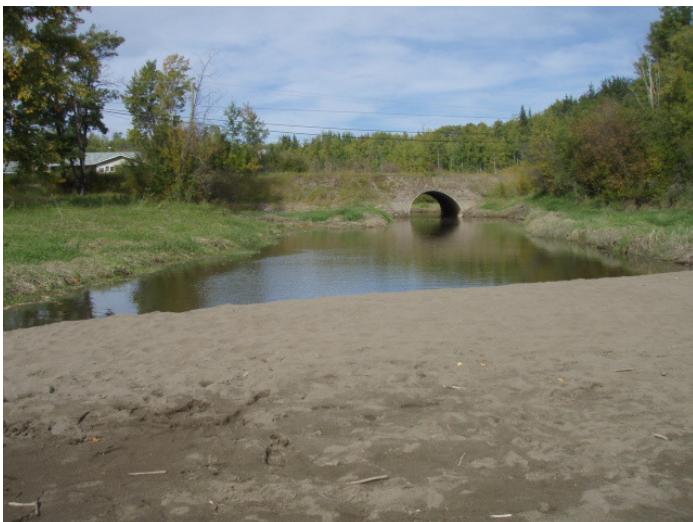
CMP01- Outlet & sediment barrier (North)

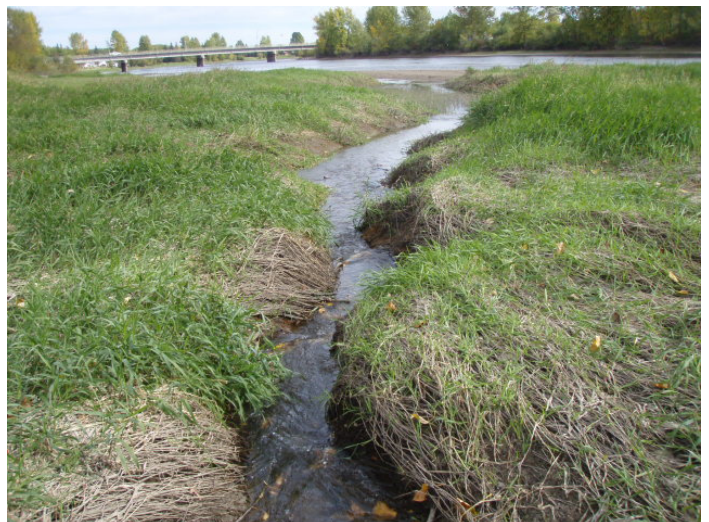
CMP01- New stream outlet looking (East)

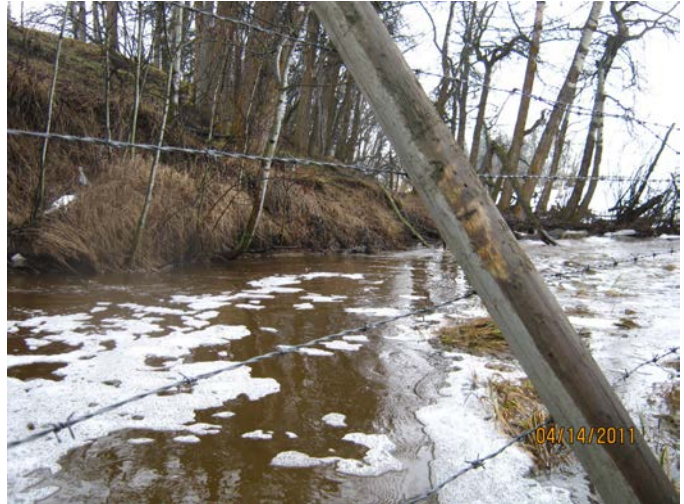
Date (mm/dd/yy)	4/13/2011		
Crossing ID #	CMP02/03		
Crew Name	OA/LN		
Stream Name	Murray Creek		
UTM	Easting	Northing	
10U	429889	5990208	
Road Name	Loop		
Crossing Type	Round Culvert	Outlet Residual Pool (m)	0.65
Embedded	None	Inlet Drop	No
Outlet Drop (cm)	0	Fill Depth (m)	9.4
Culvert Width (m)	1.52	Valley Fill	Deep Fill
Channel Width (m)	1.78	Habitat Value	Low
Stream Width Ratio (m)	1.17	Beaver Activity	No
Culvert Slope %	1.2	Backwatered	0
Stream Slope %	0.5	Fish Sighted?	No
Culvert Length (m)	32		
Fish Barrier Result			
Score	24	Result	Barrier
Stream Priority Rank	1		
Recommendation			
Fish Barrier, stream priority rank 1, habitat value low, but provides connectivity up and down stream to good habitat value areas. High priority replacement.			
Comments			
Culvert is very undersized, causing flow restriction, upstream sediment disposition creation of a wetland, and lack of channel scouring upstream of the inlet. The outlet discharge is too fast and is at an angle which is causing severe erosion of the far north bank.

CMP (02-03) - Outlet downstream (SE)

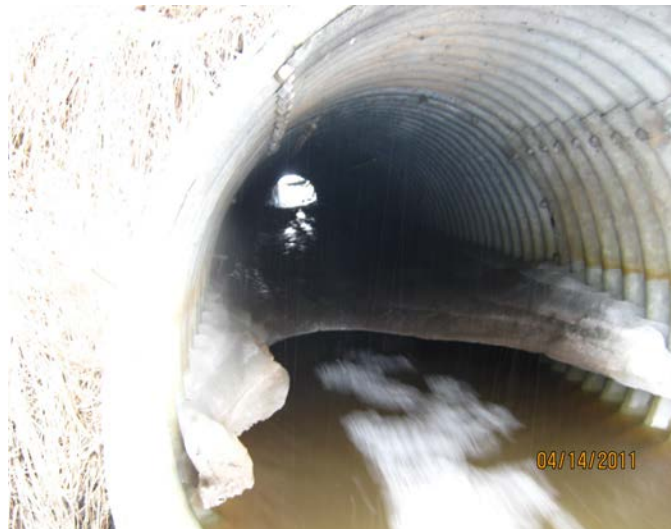
CMP (02-03) – Outlet Barrel

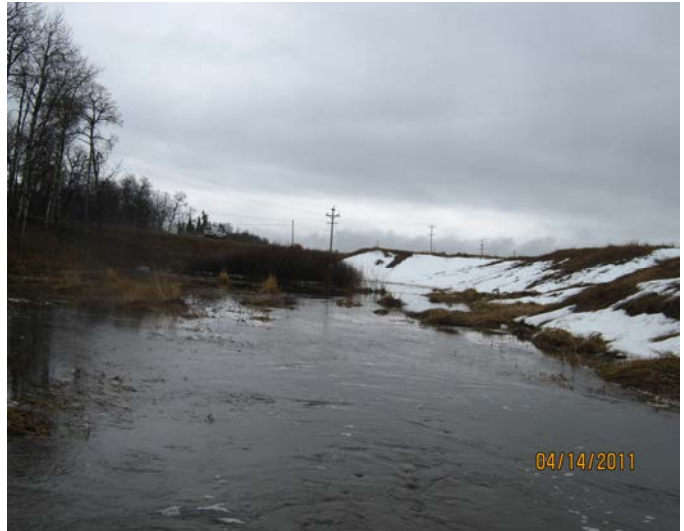
Date (mm/dd/yy)	4/14/2011		
Crossing ID #	CMP04		
Crew Name	OA/LN		
Stream Name	Murray Creek		
UTM	Easting	Northing	
	10U	429831	5990337
Road Name	Snell Rd East		
Crossing Type			
	Round Culvert	Outlet Residual Pool (m)	0.7
Embedded	None	Inlet Drop	No
Outlet Drop (cm)	0	Fill Depth (m)	2.8
Culvert Width (m)	2	Valley Fill	Deep Fill
Channel Width (m)	1.72	Habitat Value	Low
Stream Width Ratio (m)	0.86	Beaver Activity	No
Culvert Slope %	0.7	Backwatered	0
Stream Slope %	0.7	Fish Sighted?	No
Culvert Length (m)	15.1		
Fish Barrier Result			
Score	13	Result	Passable
Stream Priority Rank			
	1		
Recommendation			
Passable, stream priority rank 1, low habitat value. Low to medium replacement priority.			
Comments			
Although cattle are currently fenced out up and down stream, past cattle use has eroded channel banks, deposited sediments, and damaged riparian vegetation. The area has little riparian shrub composition and is dominated by grasses. The channel is not distinguishable in some areas at low flow as it is choked by grasses.

CMP04 - Outlet looking downstream (South)

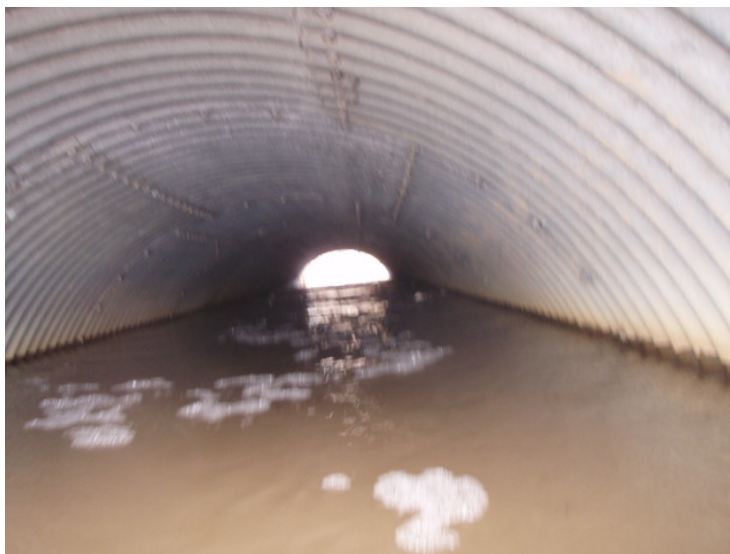
Date (mm/dd/yy)	4/15/2011		
Crossing ID #	CMP12		
Crew Name	OA/LN		
Stream Name	East Murray Creek		
UTM	Easting	Northing	
10U	431517	5990581	
Road Name	Northside Rd		
Crossing Type	Round Culvert	Outlet Residual Pool (m)	1.5
Embedded	None	Inlet Drop	No
Outlet Drop (cm)	0	Fill Depth (m)	2.8
Culvert Width (m)	2.8	Valley Fill	Deep Fill
Channel Width (m)	6	Habitat Value	Low
Stream Width Ratio (m)	2.14	Beaver Activity	No
Culvert Slope %	4.5	Backwatered	0
Stream Slope %	1	Fish Sighted?	No
Culvert Length (m)	23		
Fish Barrier Result			
Score	29	Result	Barrier
Stream Priority Rank	1		
Recommendation			
Barrier. Rank 1 stream priority, low habitat value due to past livestock use. Medium to high culvert replacement priority.			
Comments			
This culvert is undersized for this reach, is considered a barrier and needs to be replaced. Past cattle use has deteriorated the section downstream of the culvert and cows need to be excluded to help the stream recover. This section of stream is an important migration corridor to habitat up and down stream. This culvert also has a manually operated metal sheet flow restriction device used to restrict flow through the culvert and raise the water level upstream for irrigation purposes by the landowner. This may cause a temporary migration barrier for fish when it is in use. Development of another system for irrigation would be ideal.

CMP12 – Outlet Barrel

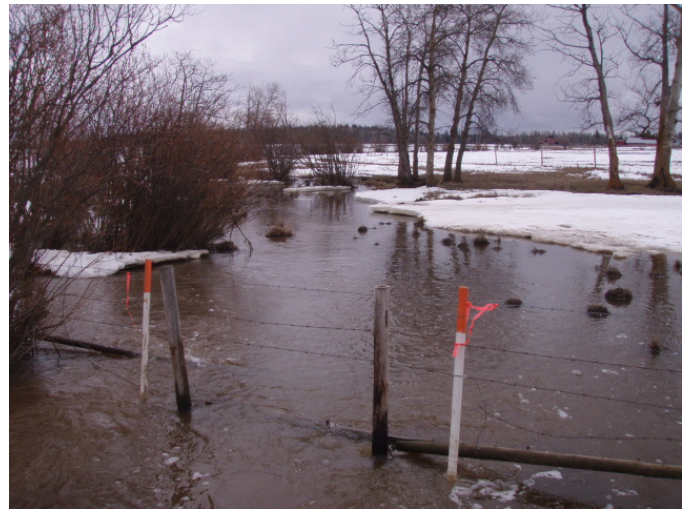
Date (mm/dd/yy)	4/13/2011		
Crossing ID #	CMP (13-14)		
Crew Name	OA/LN		
Stream Name	McIntosh Creek		
UTM	Easting	Northing	
10U	431919	5991905	
Road Name	McLeod Pit		
Crossing Type			
	Round Culvert	Outlet Residual Pool (m)	0.4
Embedded	None	Inlet Drop	No
Outlet Drop (cm)	0	Fill Depth (m)	0.5
Culvert Width (m)	1.5	Valley Fill	Deep Fill
Channel Width (m)	2.5	Habitat Value	Low
Stream Width Ratio (m)	1.67	Beaver Activity	No
Culvert Slope %	1.4	Backwatered	0
Stream Slope %	1.4	Fish Sighted?	No
Culvert Length (m)	11.5		
Fish Barrier Result			
Score	21	Result	Barrier
Stream Priority Rank			
	2		
Recommendation			
Barrier. Stream priority rank 2, low habitat value. Medium to high culvert replacement priority.			
Comments			
There are three undersized culverts at this site of which only two are functioning. They are likely a barrier, and habitat value is low downstream due to past cattle use of the stream, and slightly better upstream with good willow cover.

CMP (13-14) - Outlet downstream (South)

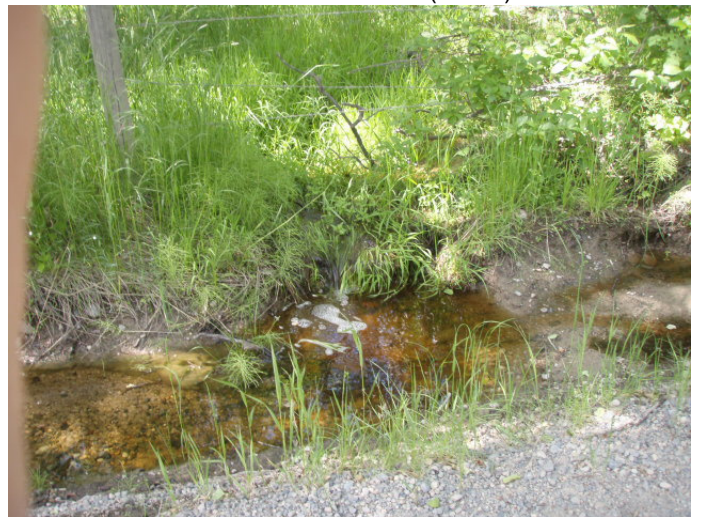
CMP25 – Stream as it enters ditch (West)
