# Stoney Creek Watershed

## Initial Assessment and Prescription for Project 3: CN Rail Crossing

**Location Description:** Culvert crossing at Stoney Creek North and West of Fountain Tire in Vanderhoof, BC.

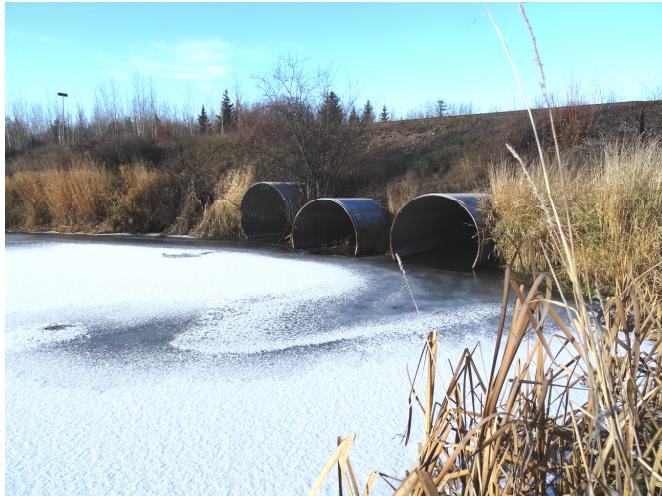
Picture 1: Culvert Inlet

There are three round closed bottom culverts at this site. There was evidence of these culverts causing erosion on to the stream bank on the Northwest stream bank. All three culverts have a partial blockage inside the culverts caused by beavers. These blockages are causing the stream to be backed up upstream for several hundred meters. Even without these blockages, it appears the culverts inlets are raised to high, and water would be still be backed up upstream although at a lower water level. The lowest of the three culverts has a 15 cm outlet drop, and the other two culverts are higher and are likely fish impediments at low water and during spring freshet before the Nechako River water levels have risen. Fish passage may be possible when the Nechako River flows are high enough to back water up and slow velocities through the culverts. These culverts were assessed as barriers and are in definite need of replacement.

- 1) Take out the culverts during low flow and replace them with a bridge.
- 2) Replace these culverts with a large diameter open bottom arch culvert that will handle freshet flows and will not impede fish passage.

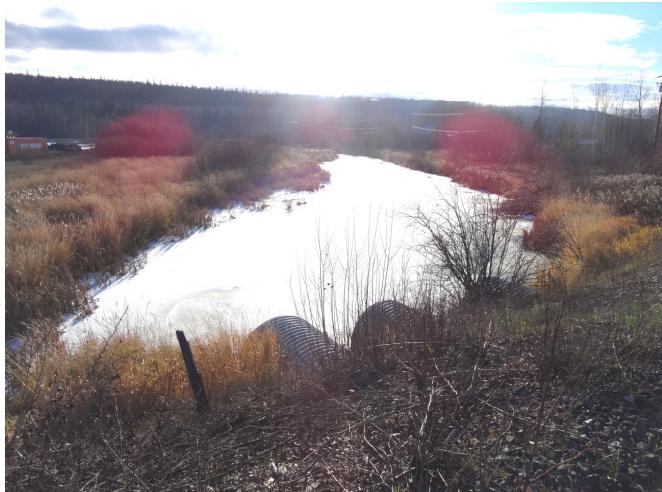
Picture 3: Upstream View

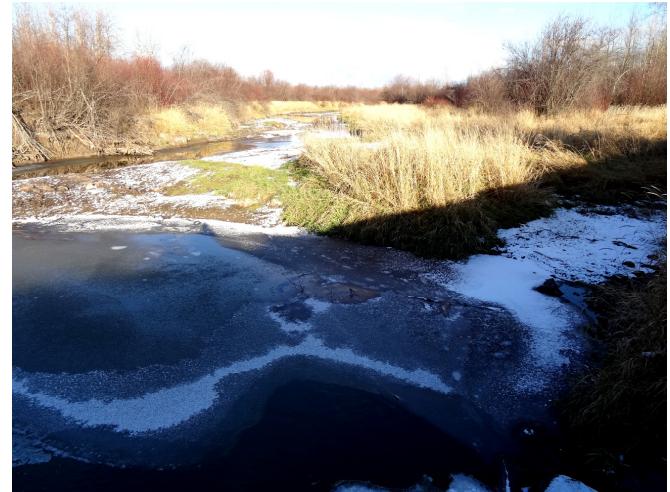
Picture 4: Downstream View

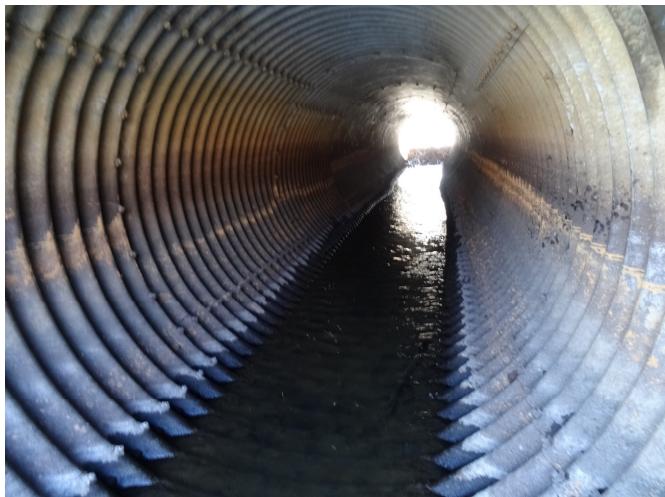
Crossing Fix	Recommended Diameter or Span (meters)	Assessment Comment
Open Bottom Structure	25	Three culverts, all the same size. Beavers have dammed inside of the culvert. Water is backed up above the culverts

Picture 5: Culvert Barrel

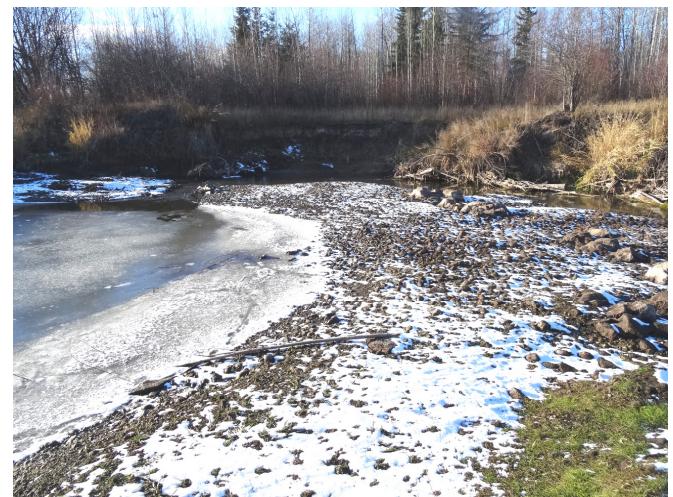
Picture 6: Down Stream Bank Erosion
