AVISON MANAGEMENT SERVICES LTD.

East Murray 2024 Stream Restoration Project – Lindsay Janzen

Date: March 31, 2025

Project No.: 24-52

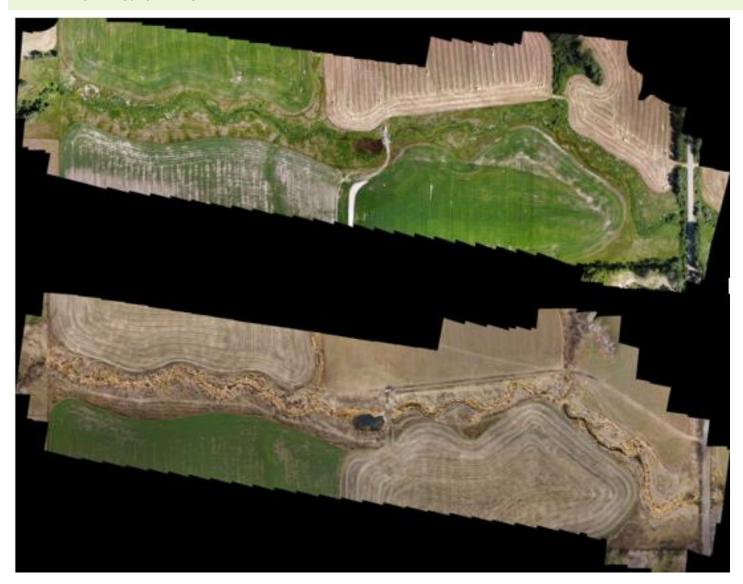
Aerial imaging of East Murray prior to BDA installation June 2024 (Above). After BDA completion October 2024 (Below).

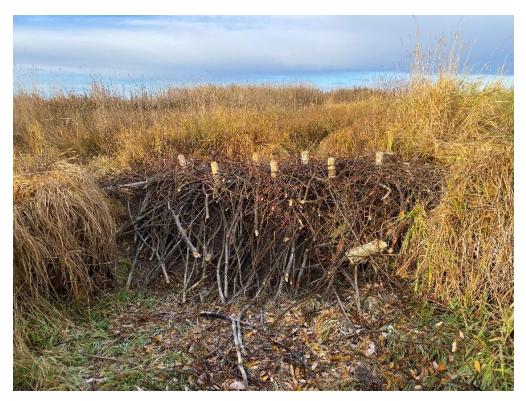
Completed BDA in-stream.

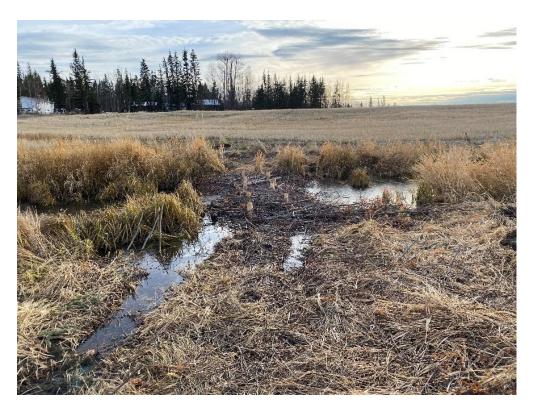
Completed BDA holding water following Fall rains.

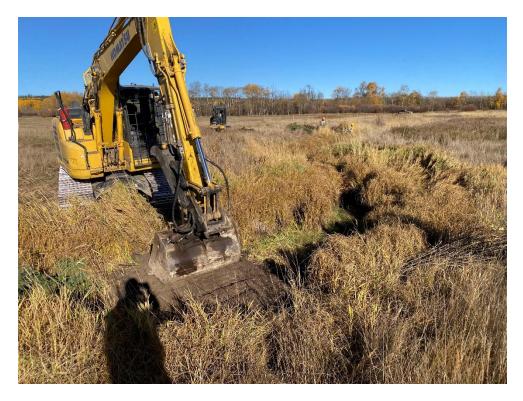
As BDA construction and willow planting required the assistance of an excavator. Heavy equipment was operated in dry conditions with minimal impact to stream bank vegetation. Work areas where chosen away from treed areas to avoid any need for clearing or grubbing.

Photo of excavator operating from above the stream bank while constructing a BDA.
