## AVISON MANAGEMENT SERVICES LTD.

### Knight Creek 2024 Stream Restoration Project – Stuart Hall

Date: January 10, 2025  
Revised: January 20, 2025  
Project No.: 24-54

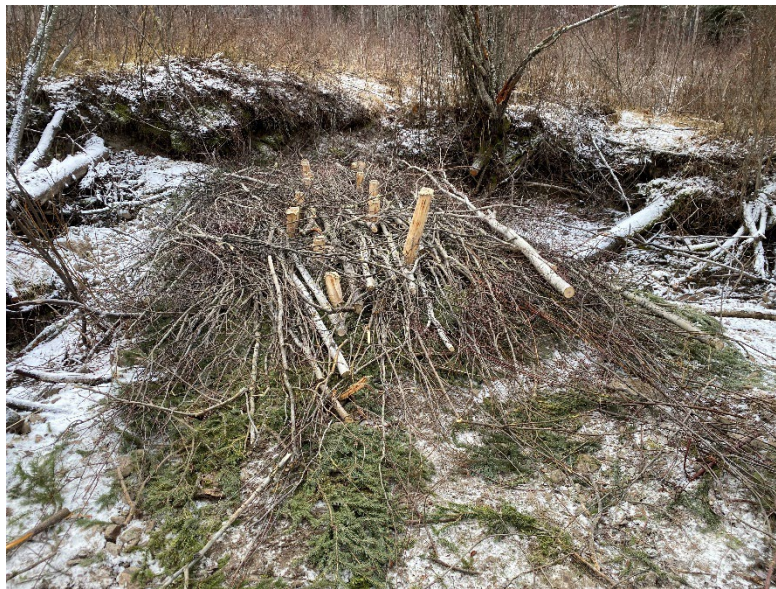
Figure 2: Completed BDA

Construction occurred while the creek was dry as this location remains dry for the majority of the year. The BDAs were built according to the designs provided by Golder (Appendix A). Each structure consisted of layered willow branches and spruce boughs, built to a maximum height of one meter, with a combined water storage capacity of less than 300m<sup>3</sup> (Table 1). The structures were capped with mud and rocks collected in situ from the local area. To finalize the structures, they were reinforced with stakes to ensure structural integrity and resilience against freshet flows (Figure 3).

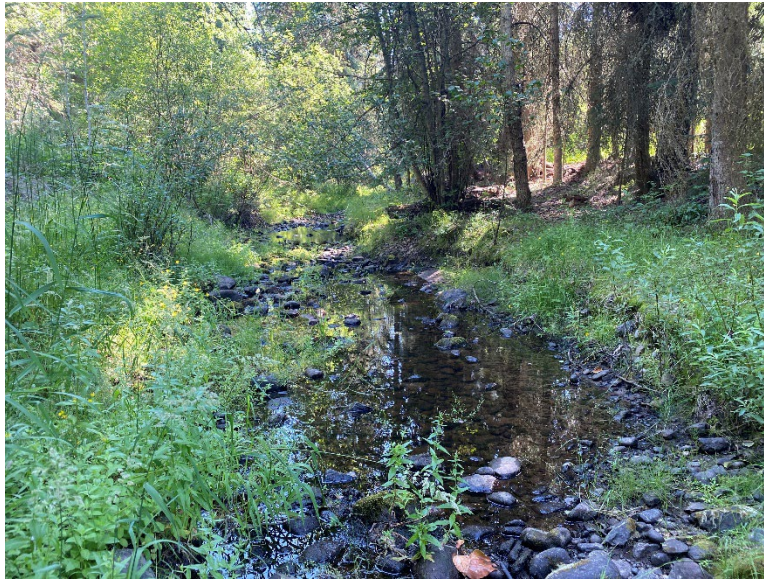
Figure 4: Knight Creek in July, after freshet, prior to BDA construction

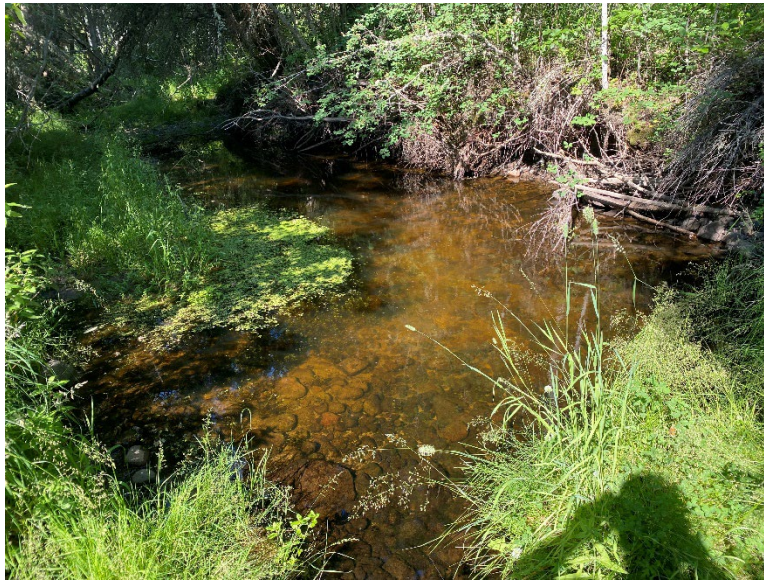
Figure 5: Knight Creek in July, after freshet, prior to BDA construction

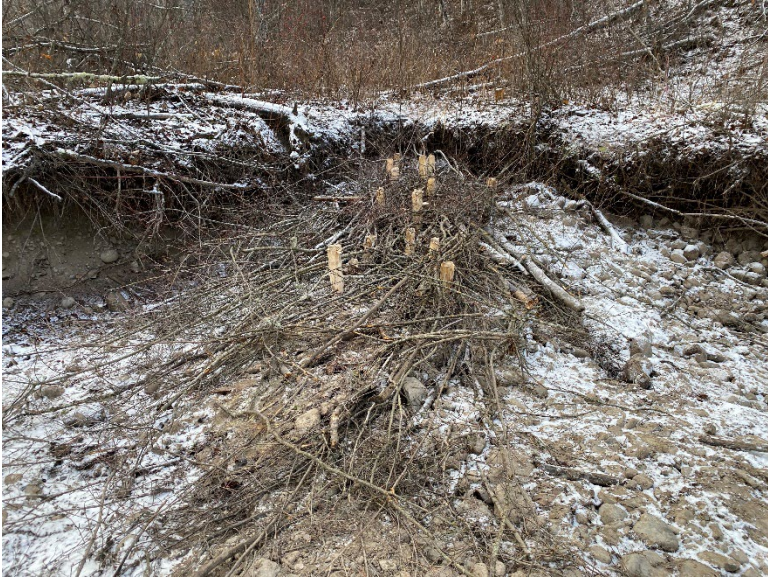
Figure 6: Completed BDA

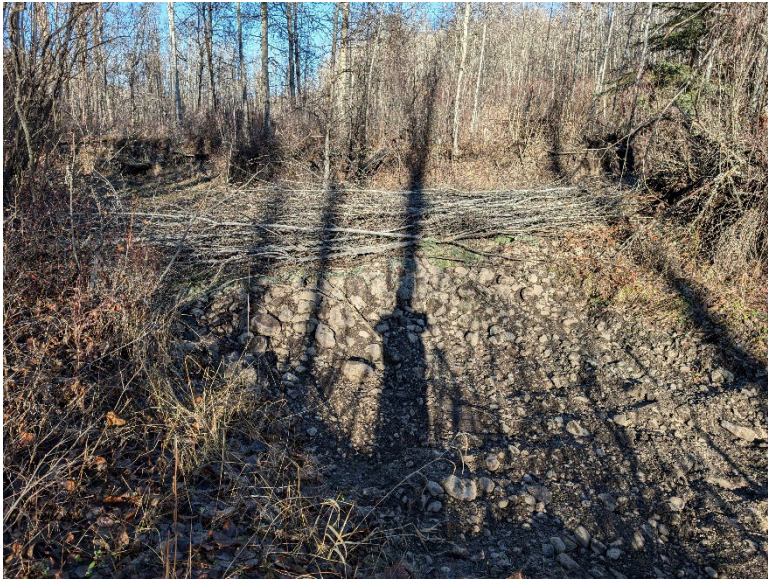
Figure 7: Completed BDA without posts

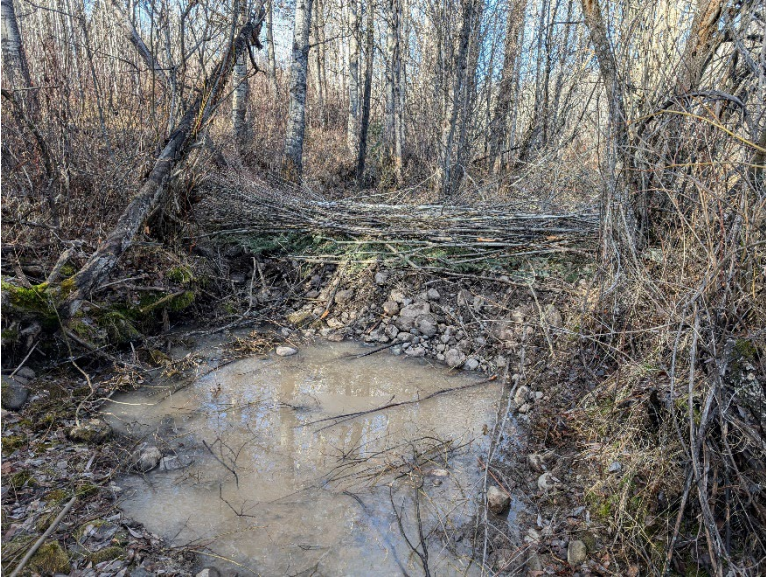
Figure 8: Completed BDA without posts
