# Jay Bangs – Unnamed Ephemeral Drainage

## Aerial Overview – Before and After BDA Installation

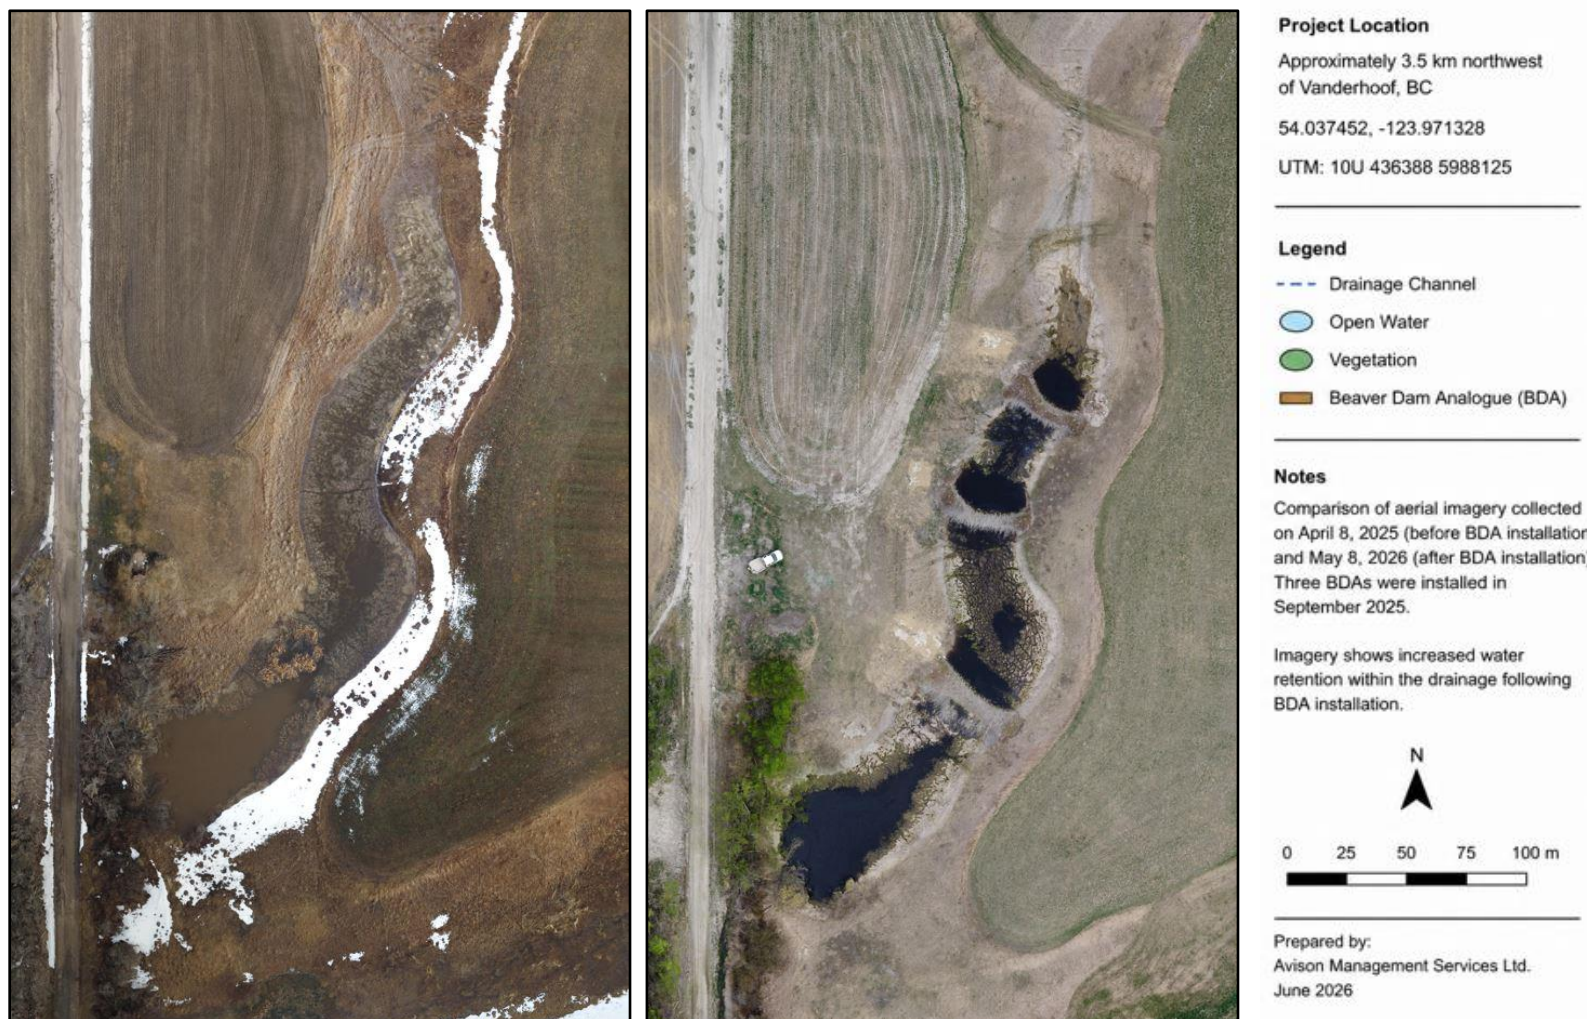
**Observations:** Imagery collected in late May 2026 (approximately 8 months after BDA installation) shows surface water retained at all three BDA locations while much of the surrounding drainage remains dry. These observations indicate that the BDAs are functioning as intended to increase water storage and extend the hydroperiod.
