Murray Creek

Culvert Assessment Report

Prepared by: Olin Albertson R.P.Bio.

Submitted: October 11, 2011
Revised: January 8, 2014

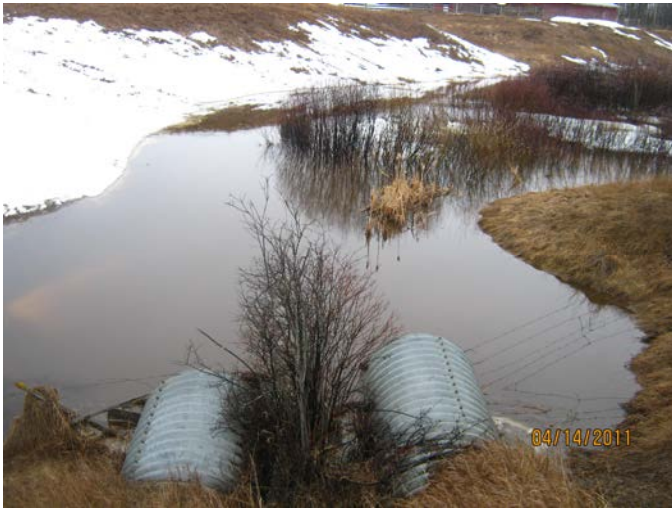
CMP (02-03) – Inlet looking (West)

Date (mm/dd/yy)	4/13/2011		
Crossing ID #	CMP02/03		
Crew Name	OA/LN		
Stream Name	Murray Creek		
UTM	Easting	Northing	
10U	429889	5990208	
Road Name	Loop		
Crossing Type	Round Culvert	Outlet Residual Pool (m)	0.65
Embedded	None	Inlet Drop	No
Outlet Drop (cm)	0	Fill Depth (m)	9.4
Culvert Width (m)	1.52	Valley Fill	Deep Fill
Channel Width (m)	1.78	Habitat Value	Low
Stream Width Ratio (m)	1.17	Beaver Activity	No
Culvert Slope %	1.2	Backwatered	0
Stream Slope %	0.5	Fish Sighted?	No
Culvert Length (m)	32		
Fish Barrier Result			
Score	24	Result	Barrier
Stream Priority Rank	1		
Recommendation			
Fish Barrier, stream priority rank 1, habitat value low, but provides connectivity up and down stream to good habitat value areas. High priority replacement.			
Comments			
Culvert is very undersized, causing flow restriction, upstream sediment disposition creation of a wetland, and lack of channel scouring upstream of the inlet. The outlet discharge is too fast and is at an angle which is causing severe erosion of the far north bank.

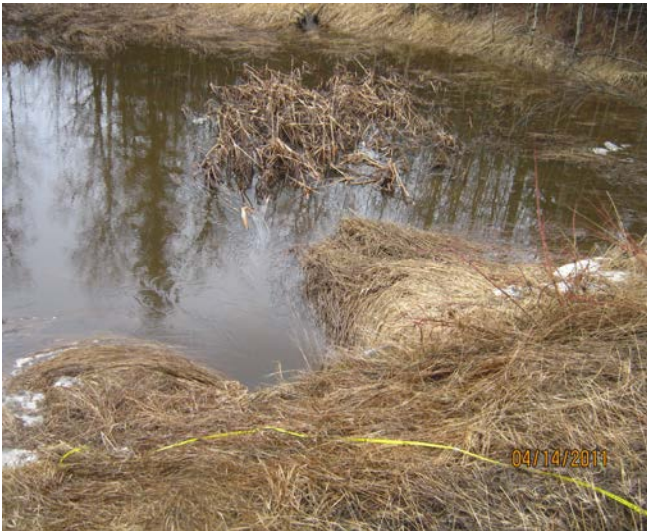
CMP04 - Inlet looking (North)

Date (mm/dd/yy)	4/14/2011		
Crossing ID #	CMP04		
Crew Name	OA/LN		
Stream Name	Murray Creek		
UTM	Easting	Northing	
	10U	429831	5990337
Road Name	Snell Rd East		
Crossing Type			
	Round Culvert	Outlet Residual Pool (m)	0.7
Embedded	None	Inlet Drop	No
Outlet Drop (cm)	0	Fill Depth (m)	2.8
Culvert Width (m)	2	Valley Fill	Deep Fill
Channel Width (m)	1.72	Habitat Value	Low
Stream Width Ratio (m)	0.86	Beaver Activity	No
Culvert Slope %	0.7	Backwatered	0
Stream Slope %	0.7	Fish Sighted?	No
Culvert Length (m)	15.1		
Fish Barrier Result			
Score	13	Result	Passable
Stream Priority Rank			
	1		
Recommendation			
Passable, stream priority rank 1, low habitat value. Low to medium replacement priority.			
Comments			
Although cattle are currently fenced out up and down stream, past cattle use has eroded channel banks, deposited sediments, and damaged riparian vegetation. The area has little riparian shrub composition and is dominated by grasses. The channel is not distinguishable in some areas at low flow as it is choked by grasses.

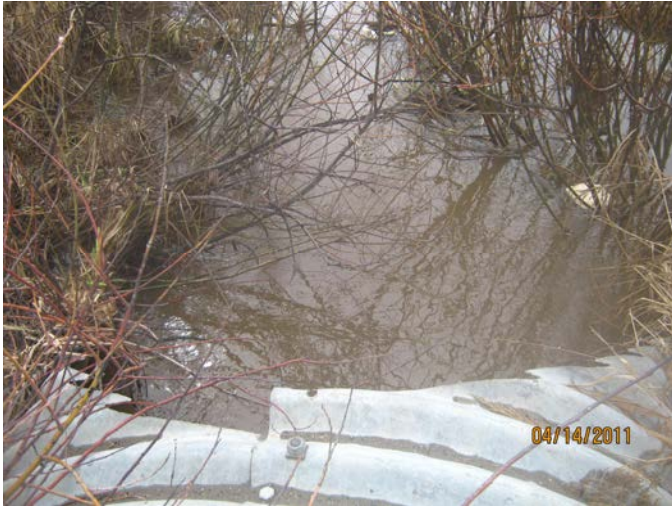
CMP05 - Outlet looking (South)

Date (mm/dd/yy)	4/14/2011		
Crossing ID #	CMP05		
Crew Name	OA/LN		
Stream Name	Murray Creek		
UTM	Easting	Northing	
10U	429075	5991962	
Road Name	Northside		
Crossing Type			
	Round Culvert	Outlet Residual Pool (m)	0.65
Embedded	None	Inlet Drop	No
Outlet Drop (cm)	0	Fill Depth (m)	1.8
Culvert Width (m)	2	Valley Fill	Deep Fill
Channel Width (m)	2	Habitat Value	Low
Stream Width Ratio (m)	1	Beaver Activity	No
Culvert Slope %	0.5	Backwatered	0
Stream Slope %	0.5	Fish Sighted?	No
Culvert Length (m)	18.3		
Fish Barrier Result			
Score	16	Result	Potential Barrier
Stream Priority Rank			
	1		
Recommendation			
Potential Barrier. Stream priority rank 1, low habitat value.			
Medium to high priority culvert replacement			
Comments			
The stream width ratio is currently 1, however the private culvert downstream approximately 200 m has backed up and slowed the creek, causing suspended sediments to fall out and collect, changing the gradient and creating a wetland. As a result this may have diminished upstream channel size of this site causing the stream width to be smaller than pre-culvert conditions. If this is the case as suspected, the culvert may be more undersized than the data indicates and a high priority culvert replacement.

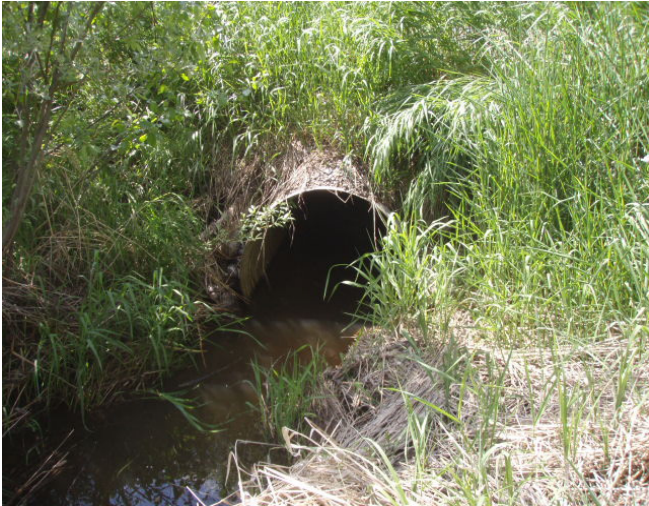
CMP (06-07) - Inlet looking (West)

Date (mm/dd/yy)	4/15/2011		
Crossing ID #	CMP (06-07)		
Crew Name	OA/BF		
Stream Name	Murray Creek		
UTM	Easting	Northing	
10U	429935	5992715	
Road Name	Larson Rd		
Crossing Type			
	Round Culvert	Outlet Residual Pool (m)	0.67
Embedded	None	Inlet Drop	No
Outlet Drop (cm)	0	Fill Depth (m)	0.75
Culvert Width (m)	1.05	Valley Fill	Deep Fill
Channel Width (m)	1.27	Habitat Value	Low
Stream Width Ratio (m)	1.21	Beaver Activity	No
Culvert Slope %	2.6	Backwatered	0
Stream Slope %	1.5	Fish Sighted?	No
Culvert Length (m)	12.2		
Fish Barrier Result			
Score	18	Result	Potential Barrier
Stream Priority Rank			
	1		
Recommendation			
Potential Barrier. Rank 1 stream priority, low habitat value, however, upstream has high habitat value. Medium to high replacement priority.			
Comments			
Directly above and below this culvert, have been influenced by past and current occasional cattle use. The stream has moved from its original course downstream which may have been influenced by the positioning of the culverts. Not only should the culverts be replaced, but a prescription to rehabilitate the creek itself is in order.

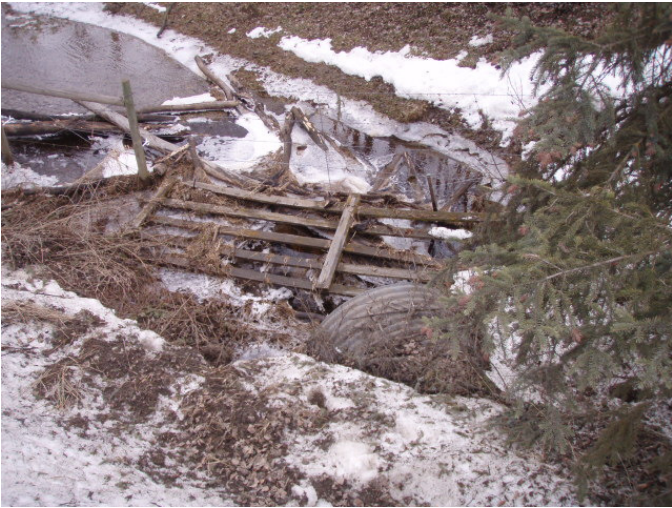
CMP10 – Inlet looking (North)

Date (mm/dd/yy)	4/15/2011		
Crossing ID #	CMP10		
Crew Name	OA/LN		
Stream Name	Unnamed Tributary to East Murray Creek		
UTM	Easting	Northing	
10U	430314	5990328	
Road Name	Snell Rd East		
Crossing Type			
	Round Culvert	Outlet Residual Pool (m)	1
Embedded	None	Inlet Drop	No
Outlet Drop (cm)	0	Fill Depth (m)	0.9
Culvert Width (m)	1.2	Valley Fill	Deep Fill
Channel Width (m)	1.8	Habitat Value	Low
Stream Width Ratio (m)	1.5	Beaver Activity	No
Culvert Slope %	2.8	Backwatered	0
Stream Slope %	4	Fish Sighted?	No
Culvert Length (m)	26		
Fish Barrier Result			
Score	29	Result	Barrier
Stream Priority Rank			
	NA		
Recommendation			
Barrier. Stream priority is not ranked, low habitat value. Low replacement priority.			
Comments			
This culvert is very much considered to be a barrier; however this is only a seasonal drainage with little to no scouring upstream. As there is no water later in the year, this is a low replacement priority.

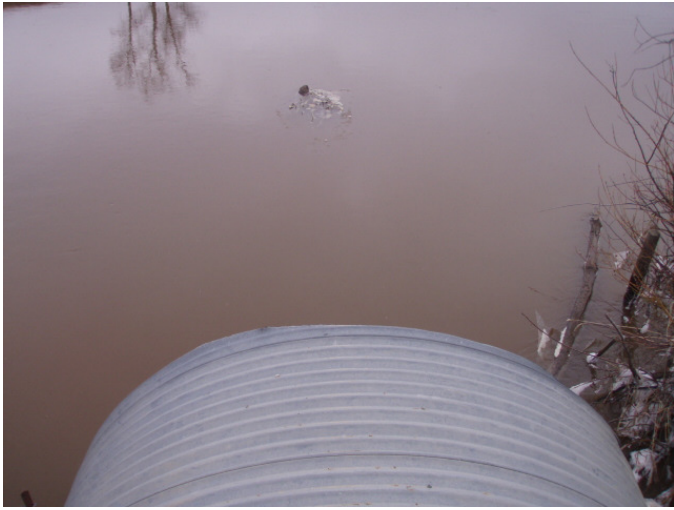
CMP11 – Inlet looking (North)

Date (mm/dd/yy)	4/15/2011		
Crossing ID #	CMP11		
Crew Name	OA/LN		
Stream Name	East Murray Creek		
UTM	Easting	Northing	
10U	430585	5990322	
Road Name	Snell Rd East		
Crossing Type			
	Round Culvert	Outlet Residual Pool (m)	1.6
Embedded	None	Inlet Drop	No
Outlet Drop (cm)	30	Fill Depth (m)	0.9
Culvert Width (m)	2.4	Valley Fill	Deep Fill
Channel Width (m)	5.3	Habitat Value	Moderate
Stream Width Ratio (m)	2.21	Beaver Activity	No
Culvert Slope %	1	Backwatered	0
Stream Slope %	1	Fish Sighted?	No
Culvert Length (m)	24		
Fish Barrier Result			
Score	29	Result	Barrier
Stream Priority Rank	1		
Recommendation			
Barrier. Stream priority rank 1, moderate habitat value. High priority culvert replacement.			
Comments			
This culvert is undersized for this reach and a barrier and needs to be replaced. Past and current cattle use has deteriorated the section upstream of the culvert and it is in bad shape. Cow's have been recently kept out of the creek downstream of culvert and is in somewhat better condition. This section of stream is an important migration corridor to habitat up and down stream.

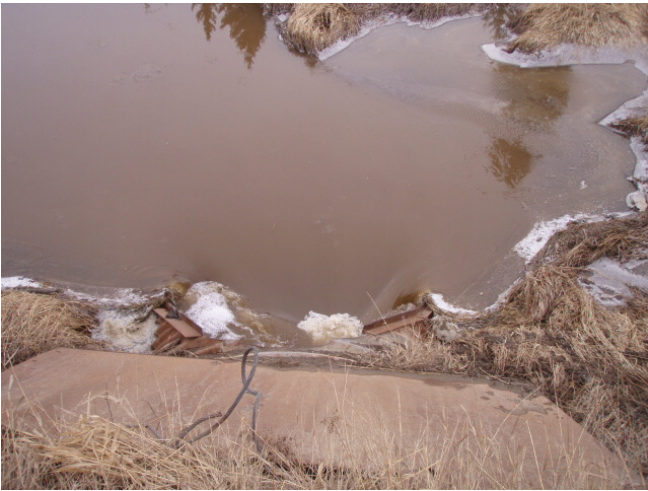
CMP12 – Inlet looking (East)

Date (mm/dd/yy)	4/15/2011		
Crossing ID #	CMP12		
Crew Name	OA/LN		
Stream Name	East Murray Creek		
UTM	Easting	Northing	
10U	431517	5990581	
Road Name	Northside Rd		
Crossing Type	Round Culvert	Outlet Residual Pool (m)	1.5
Embedded	None	Inlet Drop	No
Outlet Drop (cm)	0	Fill Depth (m)	2.8
Culvert Width (m)	2.8	Valley Fill	Deep Fill
Channel Width (m)	6	Habitat Value	Low
Stream Width Ratio (m)	2.14	Beaver Activity	No
Culvert Slope %	4.5	Backwatered	0
Stream Slope %	1	Fish Sighted?	No
Culvert Length (m)	23		
Fish Barrier Result			
Score	29	Result	Barrier
Stream Priority Rank	1		
Recommendation			
Barrier. Rank 1 stream priority, low habitat value due to past livestock use. Medium to high culvert replacement priority.			
Comments			
This culvert is undersized for this reach, is considered a barrier and needs to be replaced. Past cattle use has deteriorated the section downstream of the culvert and cows need to be excluded to help the stream recover. This section of stream is an important migration corridor to habitat up and down stream. This culvert also has a manually operated metal sheet flow restriction device used to restrict flow through the culvert and raise the water level upstream for irrigation purposes by the landowner. This may cause a temporary migration barrier for fish when it is in use. Development of another system for irrigation would be ideal.

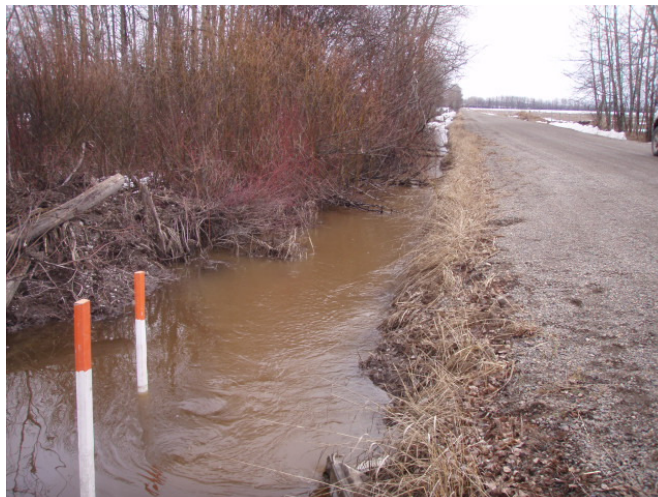
CMP (13-14) - Inlet looking at ditch runoff (East)

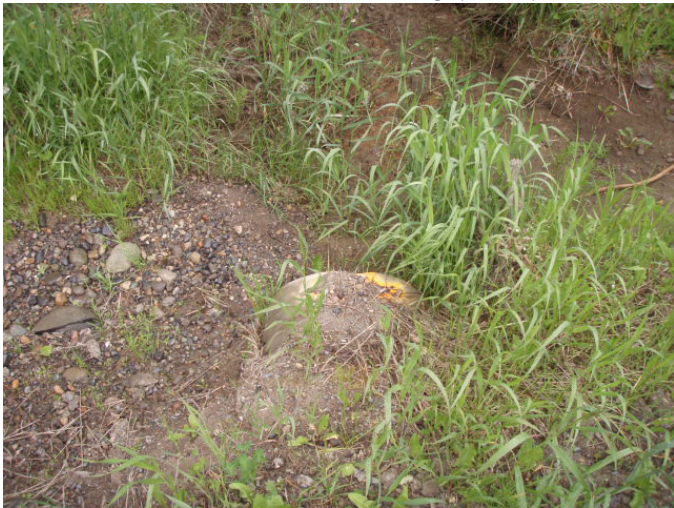
CMP15 – Outlet looking (West)

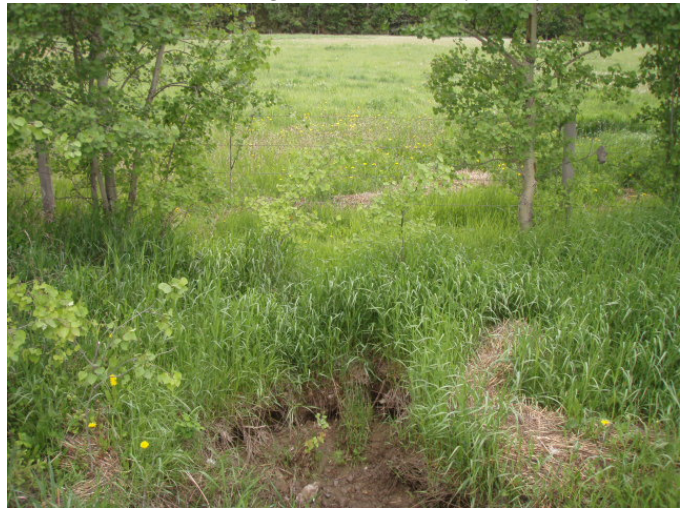
CMP15 – Outlet looking downstream (West)

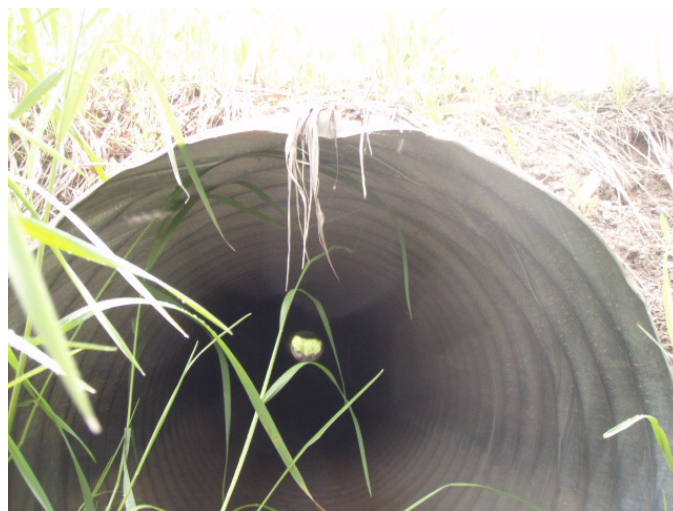
CMP15 – Outlet Barrel

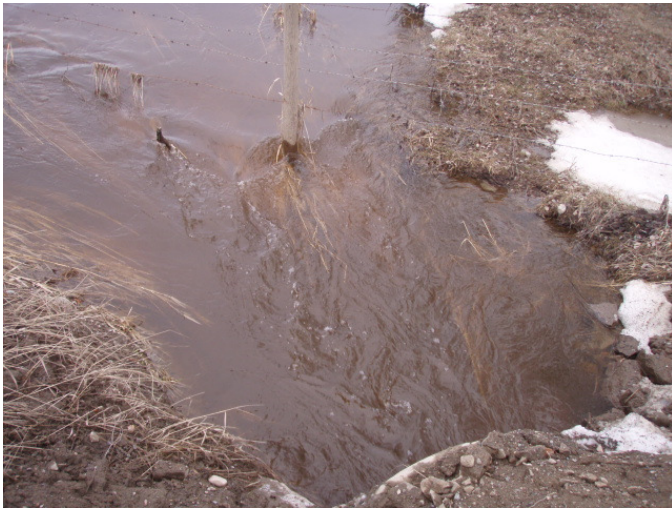
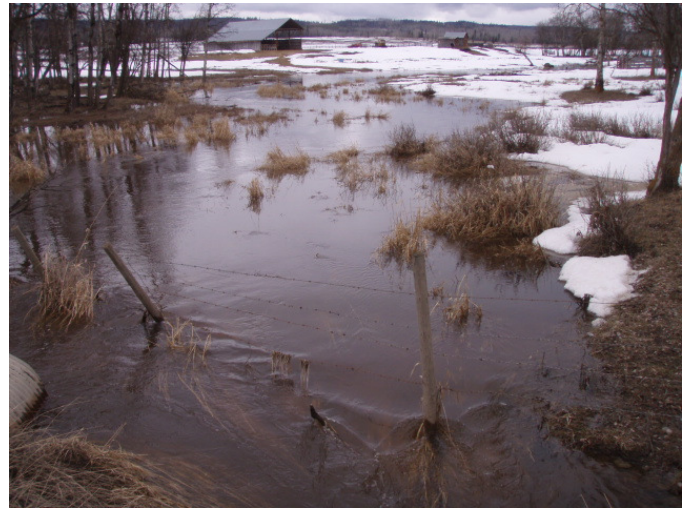
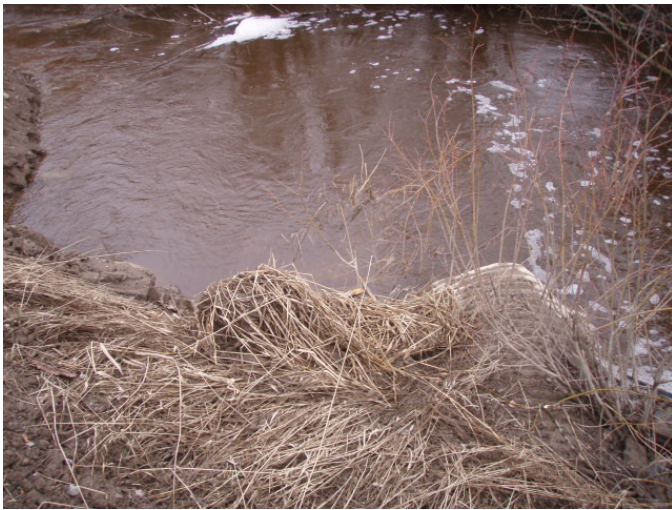
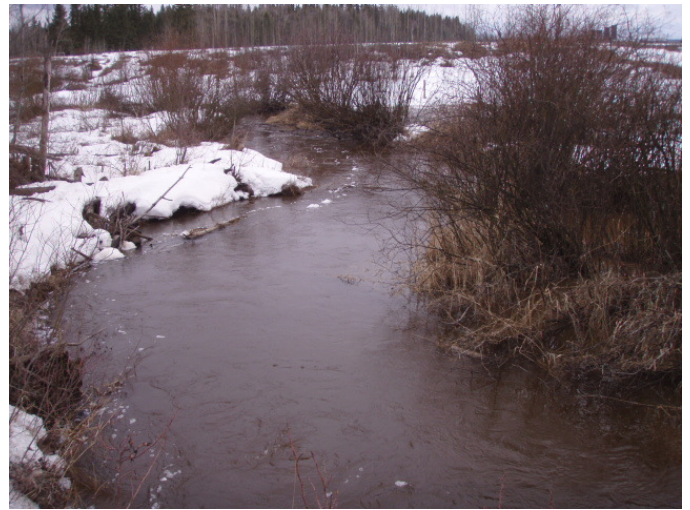
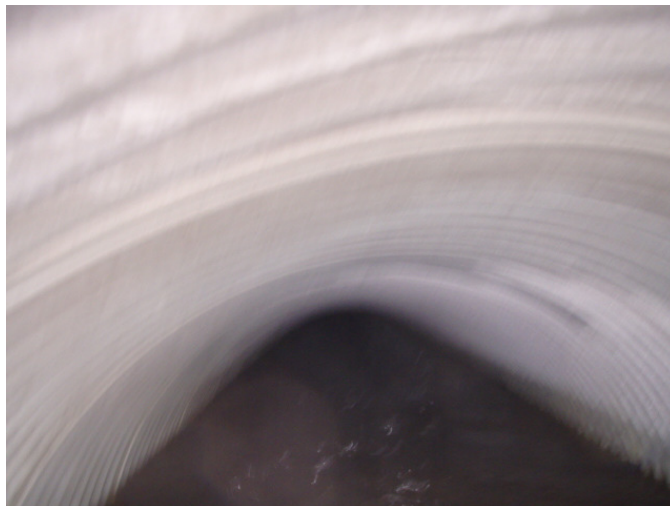
Date (mm/dd/yy)	4/14/2011		
Crossing ID #	CMP (16,17,18)		
Crew Name	OA/LN		
Stream Name	East Murray Creek		
UTM	Easting	Northing	
10U	433141	5991225	
Road Name	Striegler Road		
Crossing Type	Round Culvert	Outlet Residual Pool (m)	0
Embedded	Partial Continuous	Inlet Drop	No
Outlet Drop (cm)	0	Fill Depth (m)	1
Culvert Width (m)	2.8	Valley Fill	Deep Fill
Channel Width (m)	4	Habitat Value	Moderate
Stream Width Ratio (m)	1.43	Beaver Activity	No
Culvert Slope %	2	Backwatered	0
Stream Slope %	2	Fish Sighted?	No
Culvert Length (m)	15		
Fish Barrier Result			
Score	19	Result	Potential Barrier
Stream Priority Rank	1		
Recommendation			
Stream priority rank 1, and potential barrier. Medium to high culvert replacement priority.			
Comments			
Although there are 3 culverts at this site, and they are only considered a potential barrier, they do slow the water down on the upstream side to facilitate sediment deposit and are beginning to create a wetland with the assistance of cattle use. The habitat value is considered moderate downstream of the culvert, but low upstream.

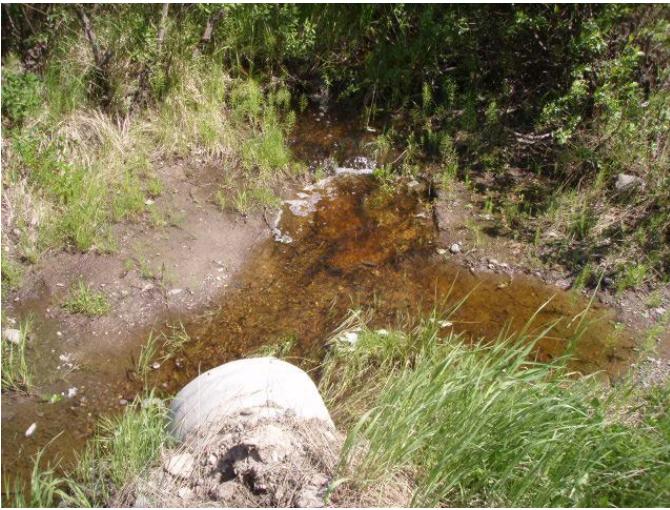
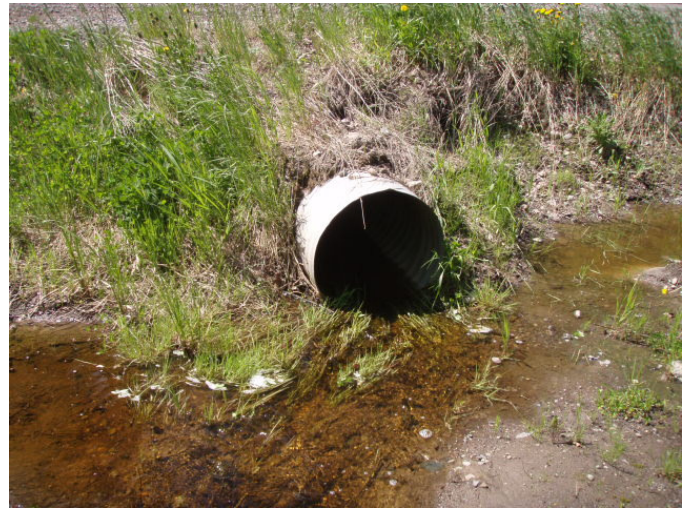
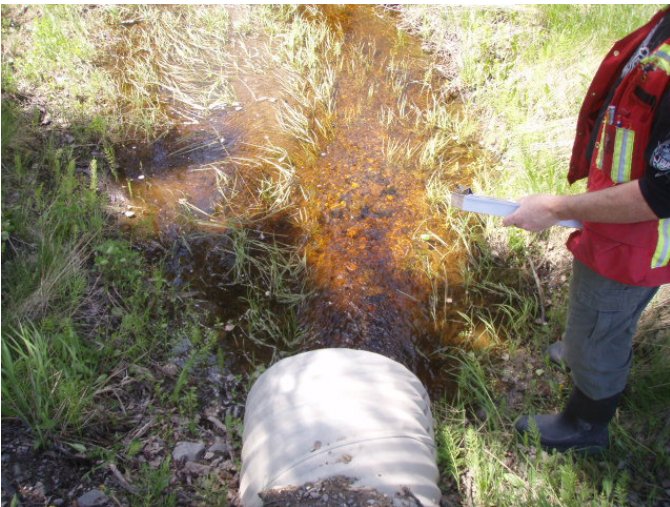
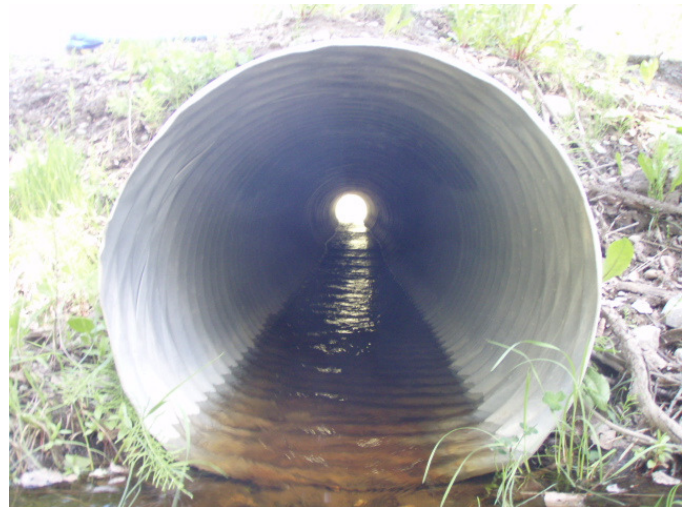
Date (mm/dd/yy)	6/7/2011		
Crossing ID #	CMP19		
Crew Name	OA/BF		
Stream Name	Unnamed tributary to East Murray Creek		
UTM	Easting	Northing	
10U	433148	5992079	
Road Name	Striegler Road		
Crossing Type	Round Culvert	Outlet Residual Pool (m)	0.07
Embedded	None	Inlet Drop	Yes
Outlet Drop (cm)	3	Fill Depth (m)	0.7
Culvert Width (m)	0.6	Valley Fill	Deep Fill
Channel Width (m)	1.48	Habitat Value	Low
Stream Width Ratio (m)	2.47	Beaver Activity	No
Culvert Slope %	1	Backwatered	0
Stream Slope %	2.5	Fish Sighted?	No
Culvert Length (m)	14		
Fish Barrier Result			
Score	16	Result	Potential Barrier
Stream Priority Rank	3		
Recommendation			
Potential Barrier. However, stream priority rank 3, low habitat value. Medium replacement culvert priority.			
Comments			
This stream crosses Striegler Road three times (CMP20/CMP19/CMP25) and then runs down the ditch downstream of CMP25 for about 300 m before entering Murray Creek below CMP16-17-18.

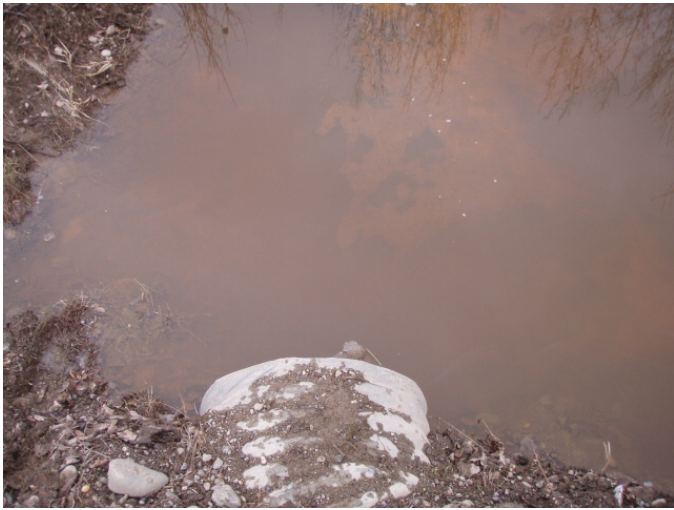
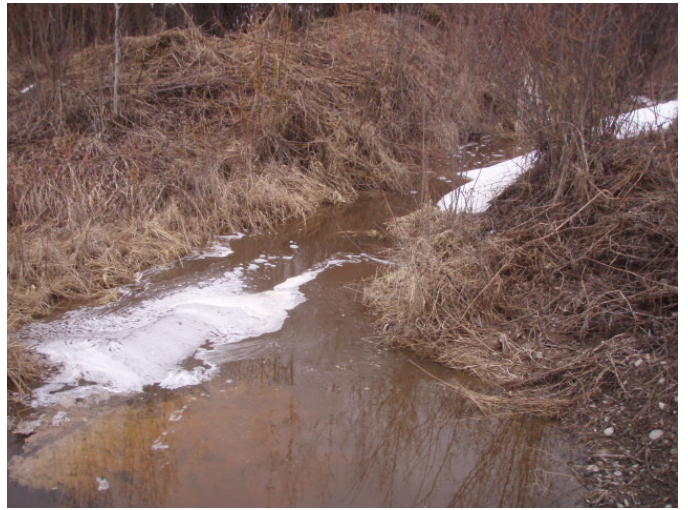
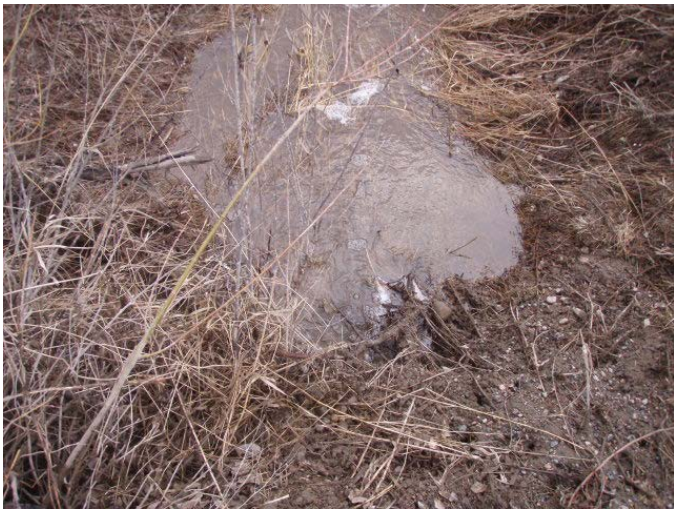
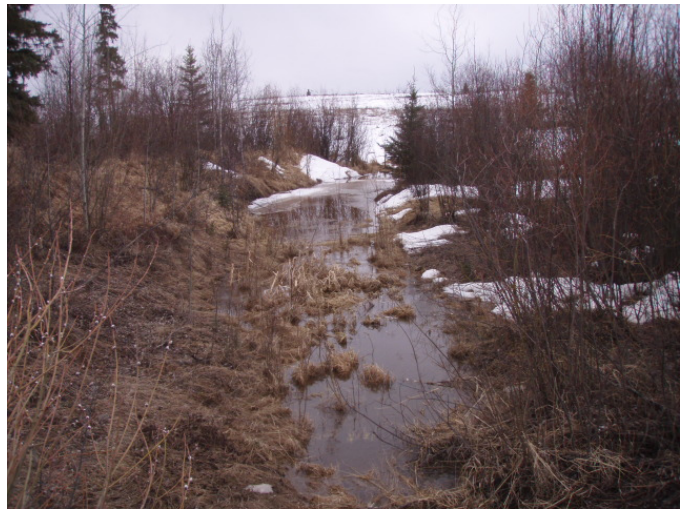
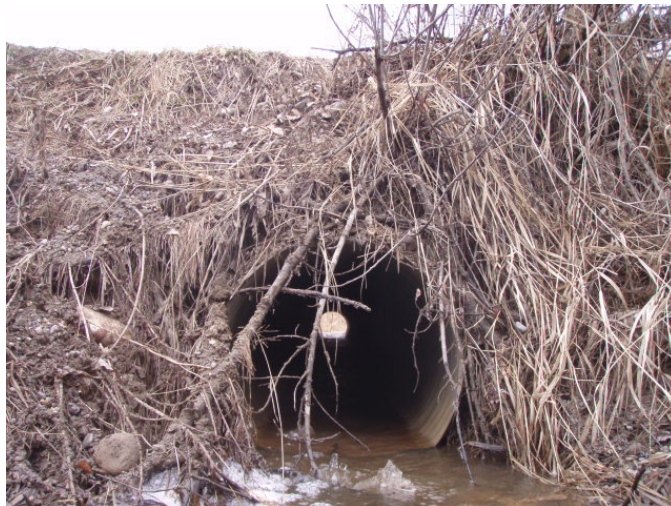
Date (mm/dd/yy)	4/13/2011		
Crossing ID #	CMP20		
Crew Name	OA/LN		
Stream Name	Unnamed tributary to East Murray Creek		
UTM	Easting	Northing	
10U	433625	5992298	
Road Name	Striegler Road		
Crossing Type			
	Round Culvert	Outlet Residual Pool (m)	0.2
Embedded	None	Inlet Drop	Yes
Outlet Drop (cm)	0	Fill Depth (m)	0.98
Culvert Width (m)	0.6	Valley Fill	Deep Fill
Channel Width (m)	2.5	Habitat Value	Low
Stream Width Ratio (m)	4.17	Beaver Activity	No
Culvert Slope %	1.9	Backwatered	0
Stream Slope %	0.06	Fish Sighted?	No
Culvert Length (m)	14		
Fish Barrier Result			
Score	21	Result	Barrier
Stream Priority Rank			
	3		
Recommendation			
Barrier. However, stream priority rank 3, low habitat value. Medium replacement priority.			
Comments			
This stream crosses Striegler Road three times (CMP20/CMP19/CMP25) and then runs down the ditch downstream of CMP25 for about 300 m before entering Murray Creek below CMP16-17-18.

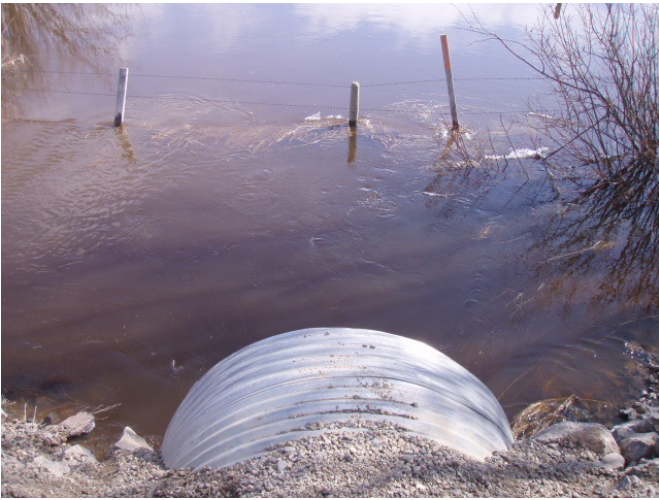
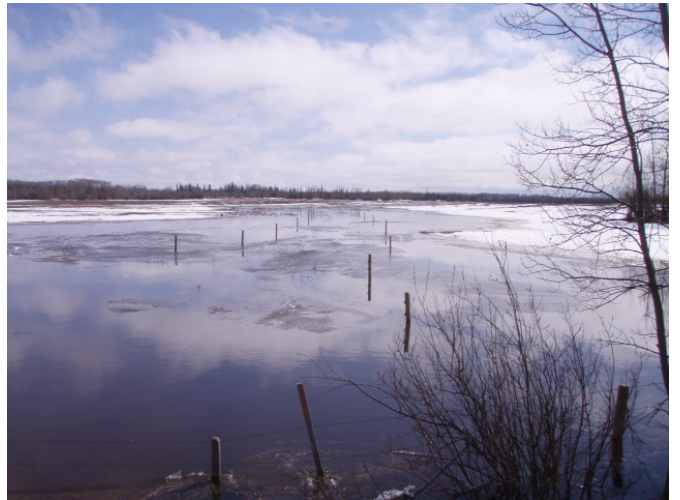
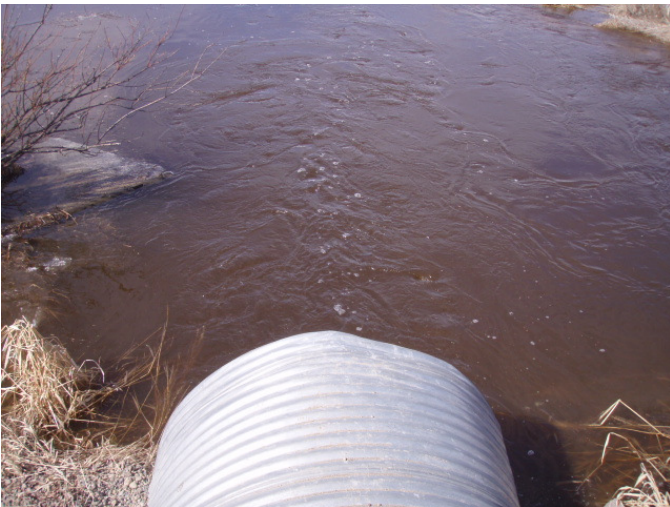
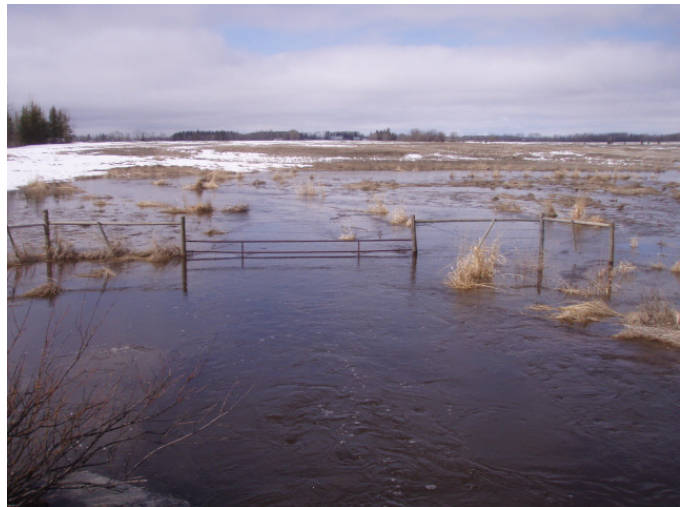
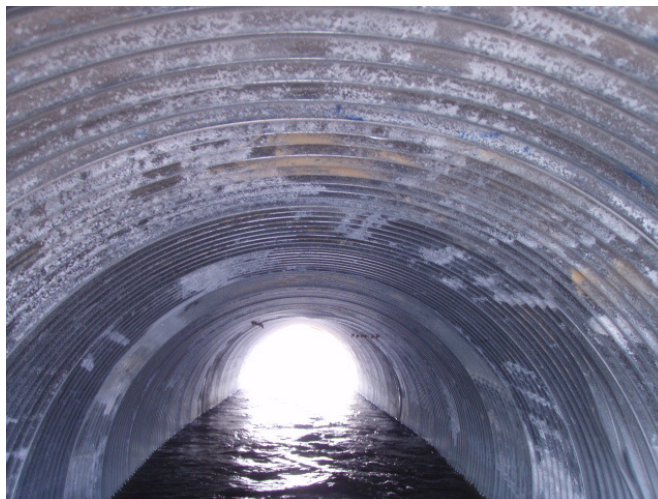
Date (mm/dd/yy)	4/15/2011		
Crossing ID #	CMP (22-23)		
Crew Name	OA/LN		
Stream Name	East Murray Creek		
UTM	Easting	Northing	
10U	434742	5991063	
Road Name	McLeod		
Crossing Type	Round Culvert	Outlet Residual Pool (m)	0.3
Embedded	None	Inlet Drop	No
Outlet Drop (cm)	0	Fill Depth (m)	0.08
Culvert Width (m)	2.8	Valley Fill	Deep Fill
Channel Width (m)	3	Habitat Value	Moderate
Stream Width Ratio (m)	1.1	Beaver Activity	No
Culvert Slope %	0.04	Backwatered	0
Stream Slope %	0.05	Fish Sighted?	No
Culvert Length (m)	12		
Fish Barrier Result			
Score	13	Result	Passable
Stream Priority Rank	2		
Recommendation			
Passable. Stream priority rank 3, moderate habitat value. Low to medium culvert replacement priority.			
Comments			
These culverts were replaced by the B.C. MOT in the last few years and are considered passable by fish. However, because these two culverts were at the same depth, the culvert widths were added together. This site would be better suited with a larger open bottomed culvert, to help keep stream morphology more natural. Both up and downstream are lacking riparian shrubs and trees and it has been cultivated up to the edge of the stream. The upstream section was recently ditched, fenced and planted with willow, although it is difficult to distinguish a channel as it is vegetated with grasses.

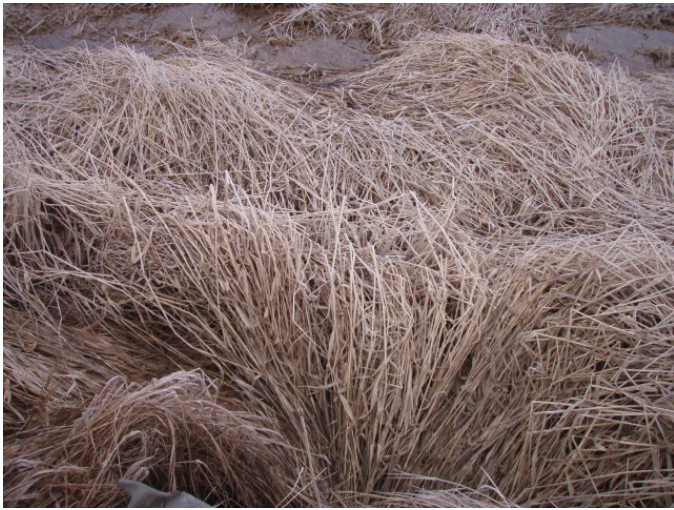
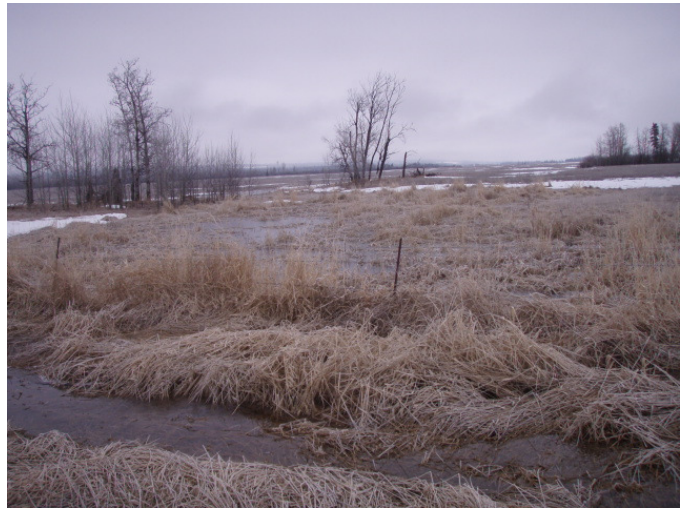
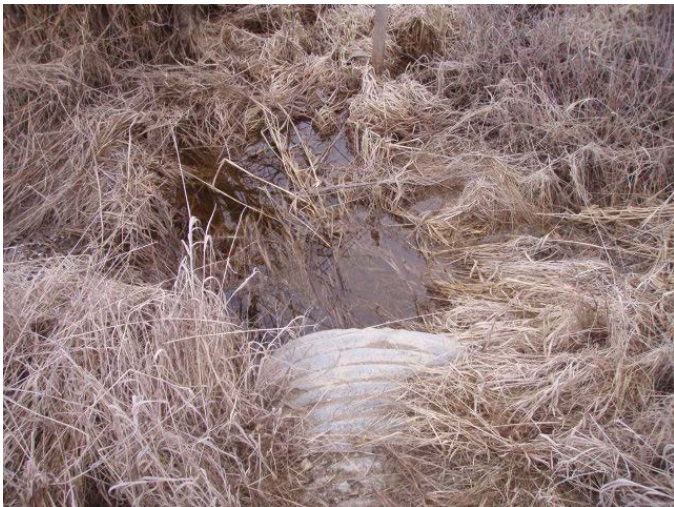
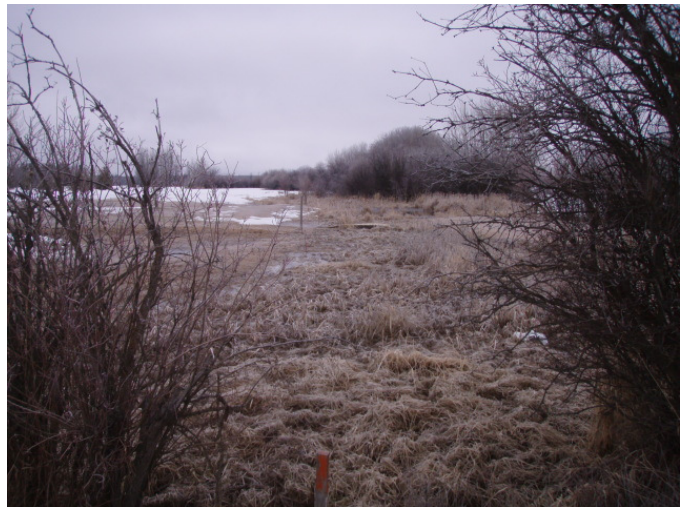
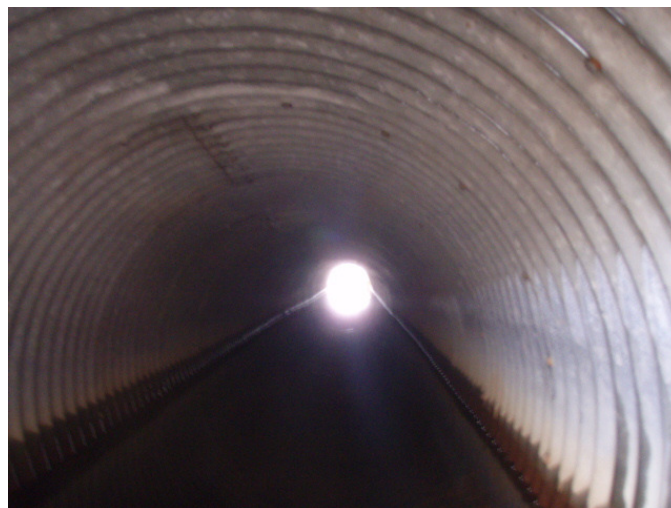
Date (mm/dd/yy)	4/14/2011		
Crossing ID #	CMP24		
Crew Name	OA/LN		
Stream Name	Unnamed tributary to Murray Creek		
UTM	Easting	Northing	
10U	434727	5989396	
Road Name	Northside		
Crossing Type	Round Culvert	Outlet Residual Pool (m)	0
Embedded	None	Inlet Drop	No
Outlet Drop (cm)	0	Fill Depth (m)	1.4
Culvert Width (m)	1	Valley Fill	Deep Fill
Channel Width (m)	NA	Habitat Value	Low
Stream Width Ratio (m)	<1	Beaver Activity	No
Culvert Slope %	0	Backwatered	0
Stream Slope %	0.01	Fish Sighted?	No
Culvert Length (m)	17		
Fish Barrier Result			
Score	13	Result	Potential Barrier
Stream Priority Rank	NA		
Recommendation			
Potential fish barrier. However, very low habitat value, dewatered most of year. Stream has not been priority ranked. Low priority culvert replacement.			
Comments			
This site is a seasonal drainage, with no scouring upstream and overgrown with grasses. Upstream is a hayfield, and downstream is a wetland. This section of steam is considered to have low habitat value.

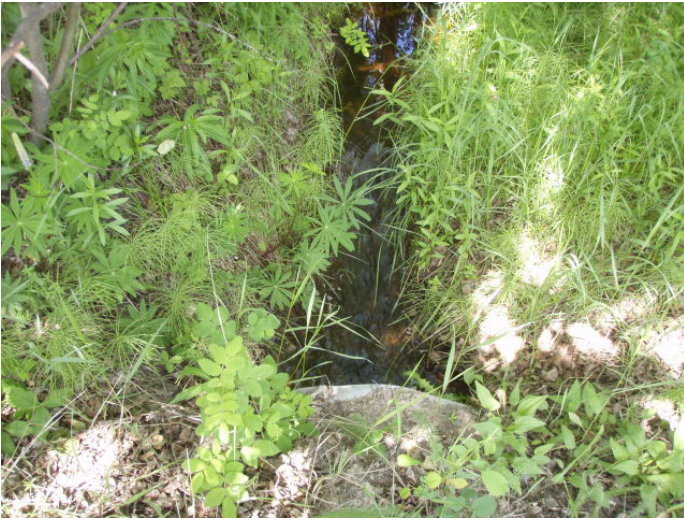
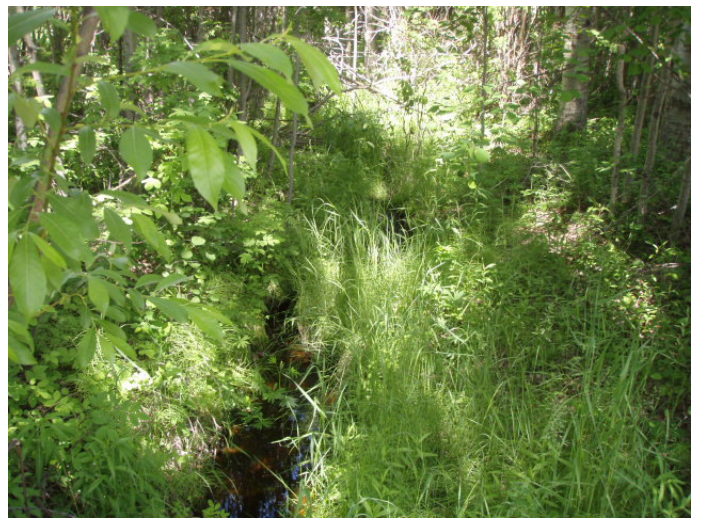
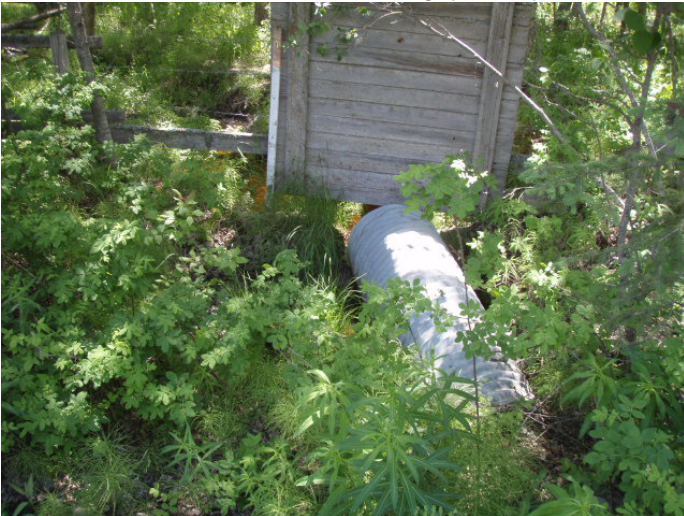
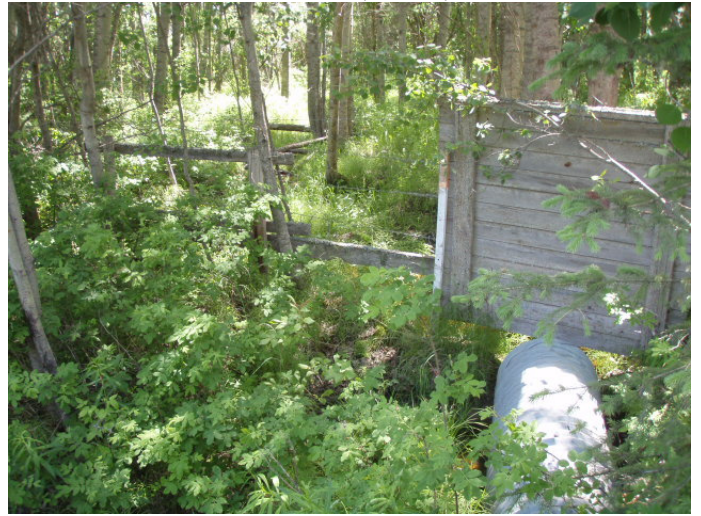
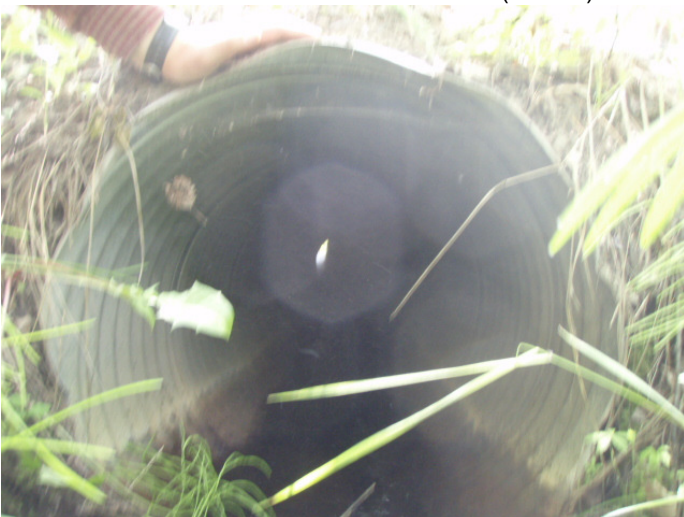
Date (mm/dd/yy)	6/7/2011		
Crossing ID #	CMP25		
Crew Name	OA		
Stream Name	Unnamed tributary to East Murray Creek		
UTM	Easting	Northing	
10U	433095	5991889	
Road Name	McLeod Pit Rd		
Crossing Type	Round Culvert	Outlet Residual Pool (m)	0.17
Embedded	None	Inlet Drop	No
Outlet Drop (cm)	0	Fill Depth (m)	0.5
Culvert Width (m)	0.6	Valley Fill	Deep Fill
Channel Width (m)	1	Habitat Value	Low
Stream Width Ratio (m)	1.67	Beaver Activity	No
Culvert Slope %	1.5	Backwatered	0
Stream Slope %	1.8	Fish Sighted?	No
Culvert Length (m)	30.5		
Fish Barrier Result			
Score	27	Result	Barrier
Stream Priority Rank	3		
Recommendation			
Barrier. Stream priority rank 3, low habitat value. Medium replacement priority.			
Comments			
This stream crosses McLeod Pit Road three times (CMP20/CMP19/CMP25) and then runs down the ditch downstream of CMP25 for about 300 m before entering Murray Creek below CMP16-17-18.			
Photos	6

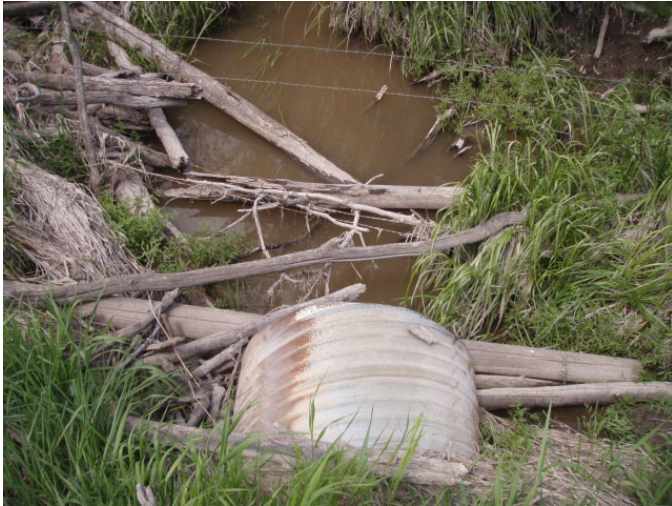
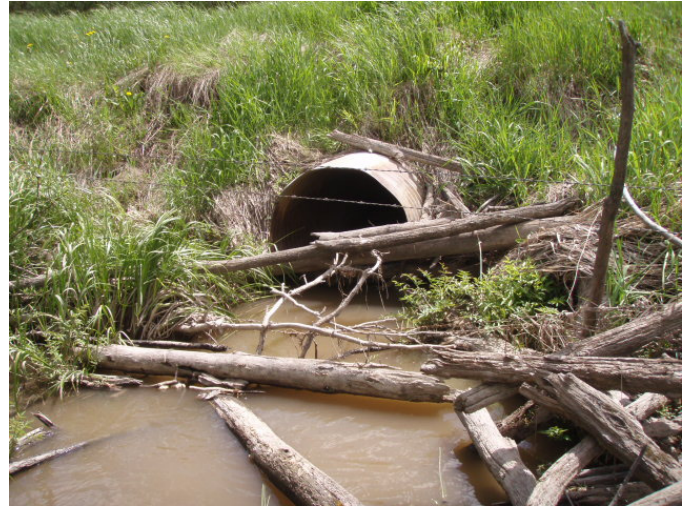
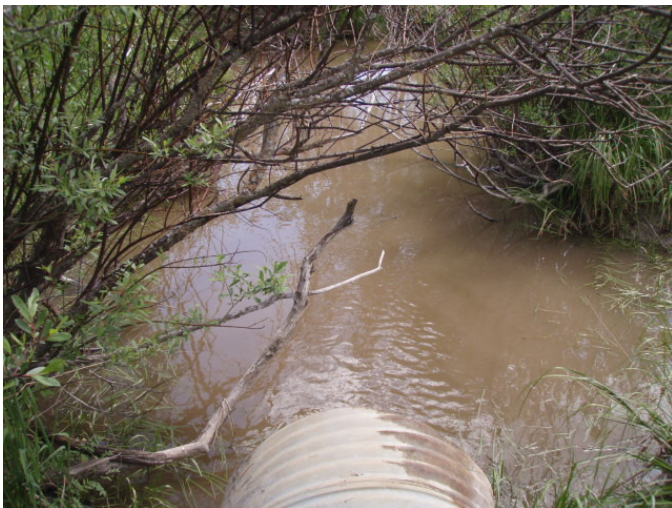
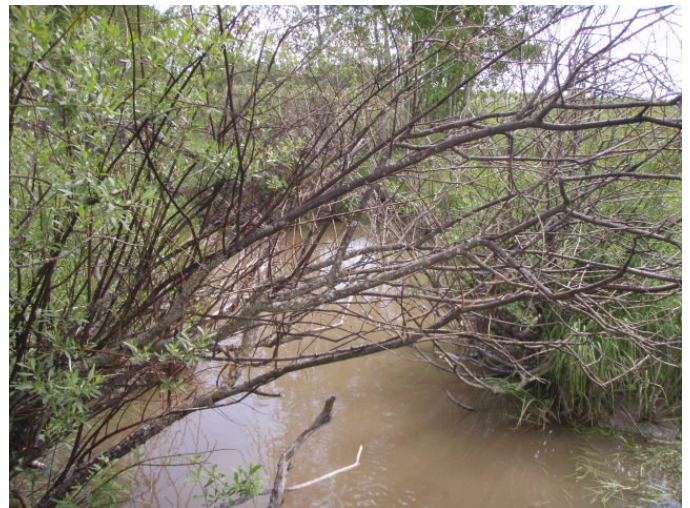
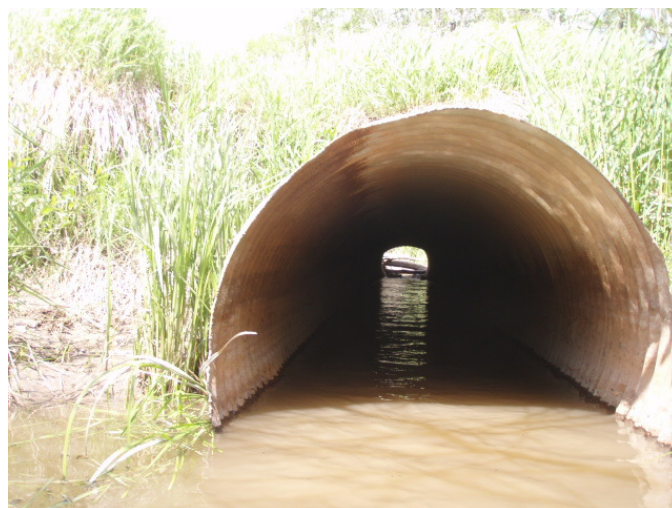
Date (mm/dd/yy)	6/11/2011		
Crossing ID #	Private CMP03		
Crew Name	OA		
Stream Name	Murray Creek		
UTM	Easting	Northing	
10U	429501	5991111	
Road Name	Private access off of Loop Rd		
Crossing Type			
	Round Culvert	Outlet Residual Pool (m)	0.52
Embedded	None	Inlet Drop	No
Outlet Drop (cm)	0	Fill Depth (m)	0.95
Culvert Width (m)	0.97	Valley Fill	Deep Fill
Channel Width (m)	1.63	Habitat Value	Low
Stream Width Ratio (m)	1.68	Beaver Activity	No
Culvert Slope %	1	Backwatered	0
Stream Slope %	1	Fish Sighted?	No
Culvert Length (m)	13.5		
Fish Barrier Result			
Score	21	Result	Barrier
Stream Priority Rank			
	1		
Recommendation			
Fish barrier, stream priority rank 1, low habitat value, however barrier to good habitat value up and down stream. High priority culvert replacement.			
Comments			
This culvert is considered a barrier. Willow and aspen line most of the stream through this section. This section is recovering from past cattle use. The stream is very turbid from upstream sediments. There are few gravels or cobbles. The substrate is dominated by clay and sediments.

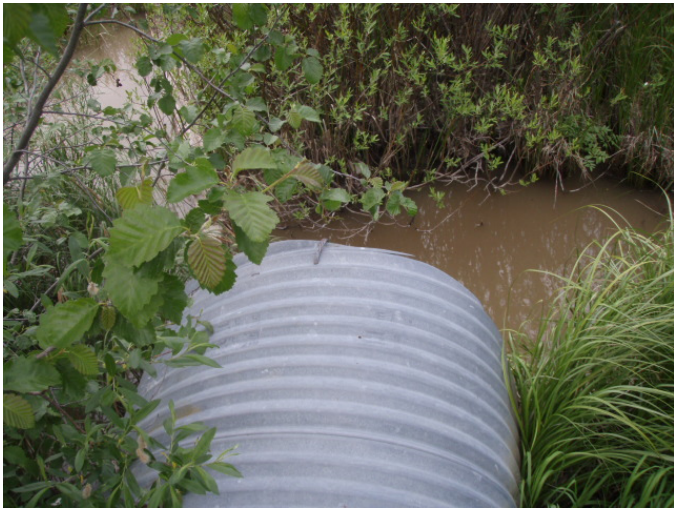
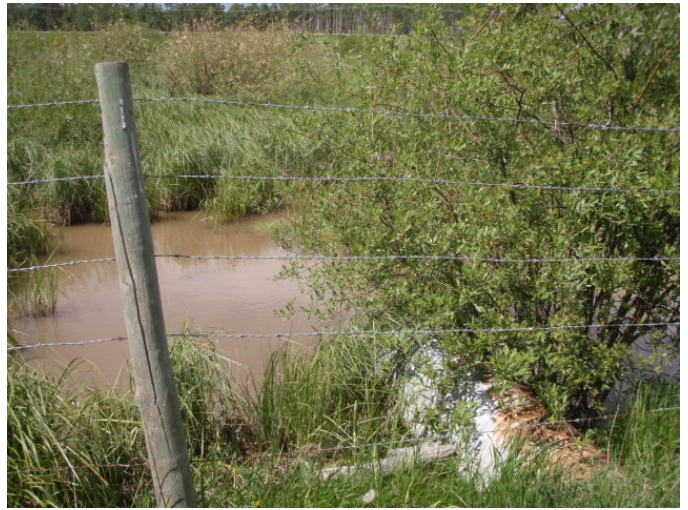
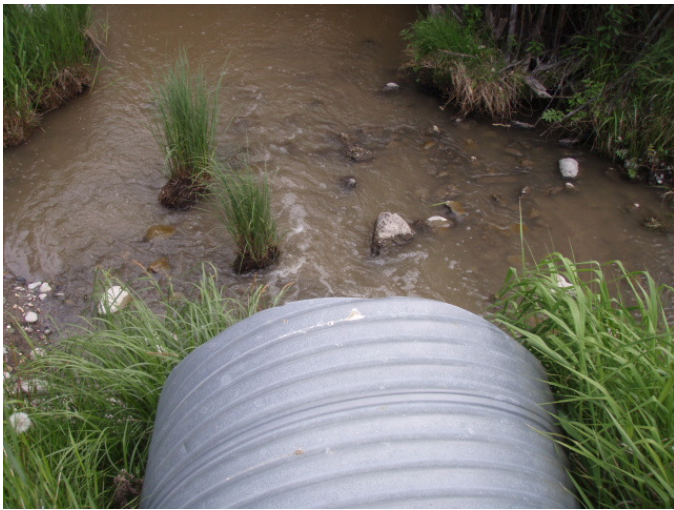
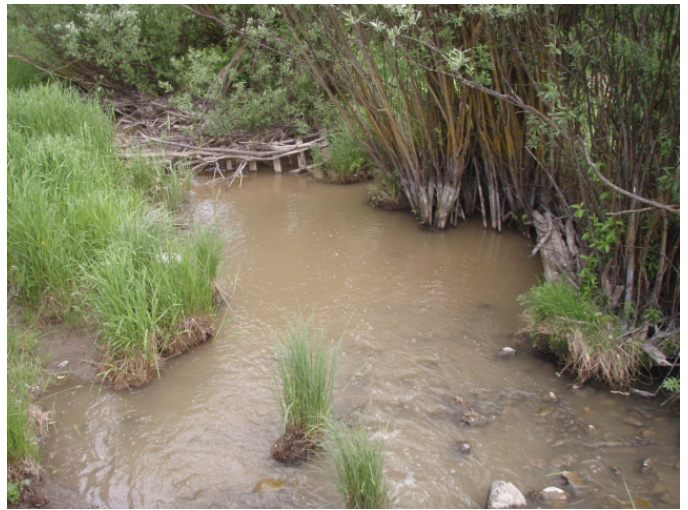
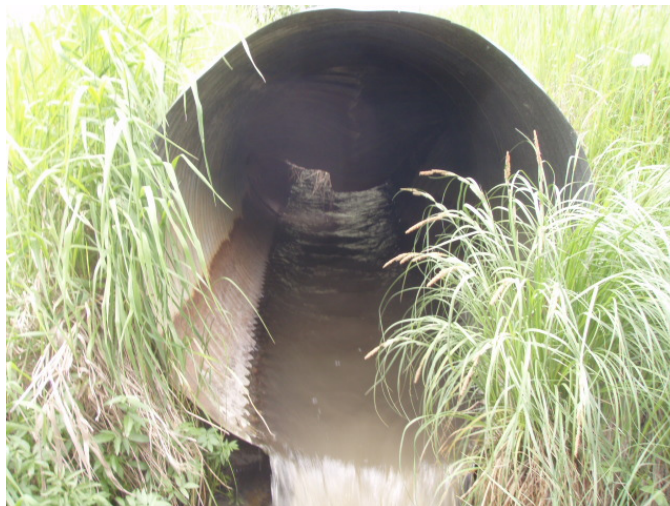
Date (mm/dd/yy)	6/11/2011		
Crossing ID #	Private CMP04		
Crew Name	OA		
Stream Name	Murray Creek		
UTM	Easting	Northing	
10U	429045	5991660	
Road Name	Private access off of Northside Rd		
Crossing Type	Round Culvert	Outlet Residual Pool (m)	0.05
Embedded	None	Inlet Drop	No
Outlet Drop (cm)	24	Fill Depth (m)	0.1
Culvert Width (m)	1.18	Valley Fill	Deep Fill
Channel Width (m)	2.55	Habitat Value	Low
Stream Width Ratio (m)	2.16	Beaver Activity	No
Culvert Slope %	2	Backwatered	0
Stream Slope %	1.5	Fish Sighted?	No
Culvert Length (m)	9		
Fish Barrier Result			
Score	26	Result	Barrier
Stream Priority Rank	1		
Recommendation			
Fish barrier, stream priority stream rank 1, low habitat value, however barrier to good habitat value up and down stream. High priority culvert replacement.			
Comments			
This site once had three culverts. Only two are still functioning and both culverts have raised inlets and outlets. This has caused upstream sediment disposition creation of an extensive wetland, and lack of channel scouring upstream of the inlet. One of the culverts was either taken out or washed out sometime in the past which has helped alleviate some of the flow restriction from these undersized culverts, but not eliminated the problem. Cattle were just recently fenced out of this area and the wetland is showing signs of recovery.
