Murray Creek

Culvert Assessment Report

Prepared by: Olin Albertson R.P.Bio.

Submitted: October 11, 2011
Revised: January 8, 2014

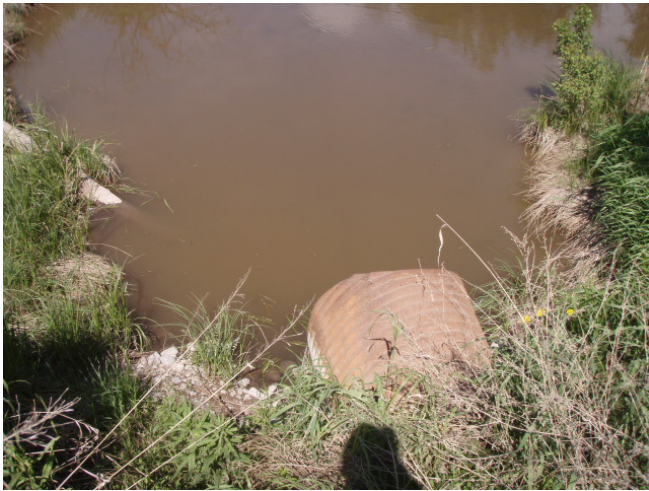
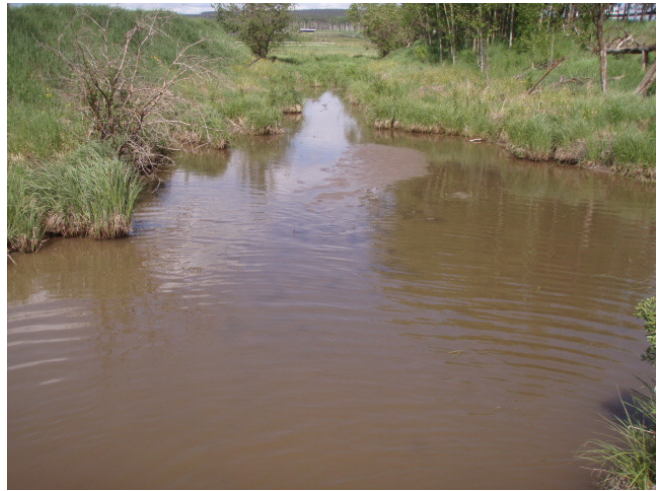
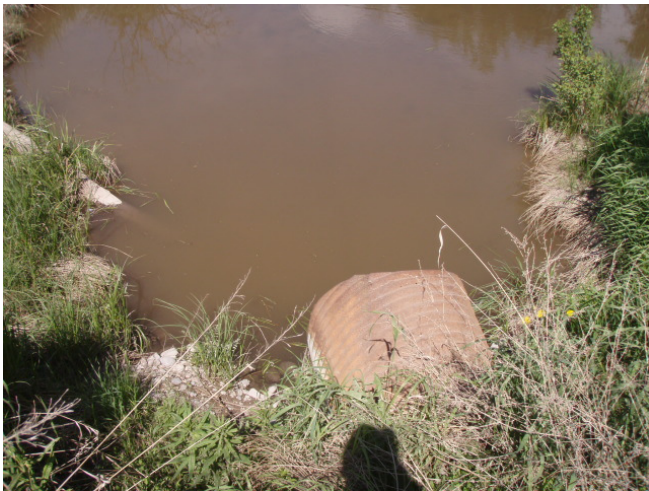
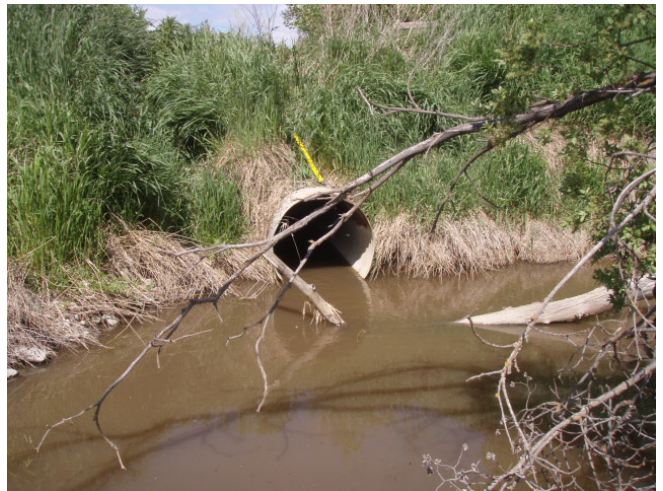
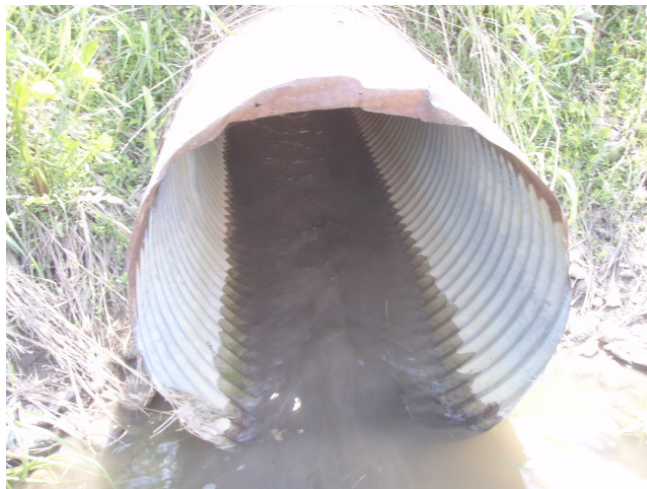
Date (mm/dd/yy)	6/11/2011		
Crossing ID #	Private CMP05		
Crew Name	OA		
Stream Name	McIntosh Creek		
UTM	Easting	Northing	
10U	432074	5991151	
Road Name	Private access off of Northside Rd		
Crossing Type	Round Culvert	Outlet Residual Pool (m)	0.43
Embedded	None	Inlet Drop	No
Outlet Drop (cm)	0	Fill Depth (m)	1.61
Culvert Width (m)	0.89	Valley Fill	Deep Fill
Channel Width (m)	2.55	Habitat Value	Low
Stream Width Ratio (m)	2.87	Beaver Activity	No
Culvert Slope %	1	Backwatered	0
Stream Slope %	1	Fish Sighted?	No
Culvert Length (m)	13		
Fish Barrier Result			
Score	24	Result	Barrier
Stream Priority Rank	2		
Recommendation			
Fish barrier, stream priority rank 2 , low habitat value, however barrier to good habitat value up and down stream. High priority culvert replacement.			
Comments			
This culvert is undersized and considered a barrier. This section of the stream is directly behind a dairy. The substrate is dominated by a heavy layer of silt, evidence of past manure management practices. However, it does appear as evidenced by an earthen berm, in which the dairy operator is attempting to prevent additional manure waste from directly entering the stream.

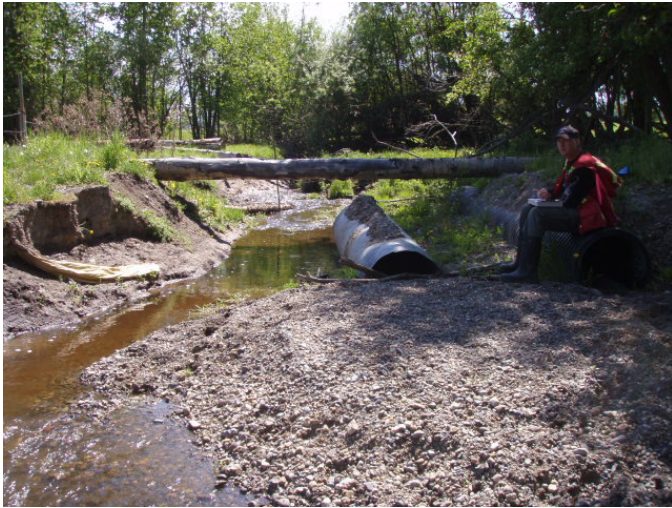
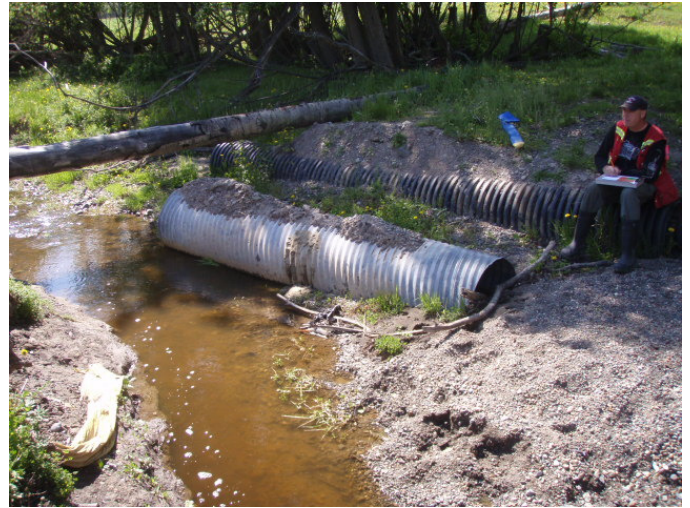
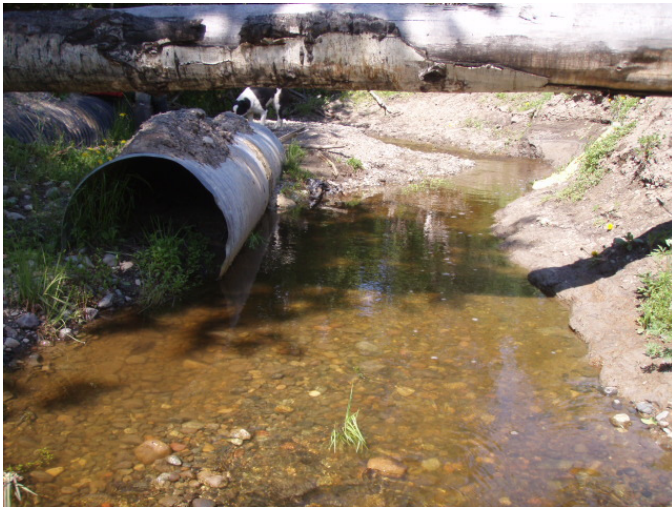
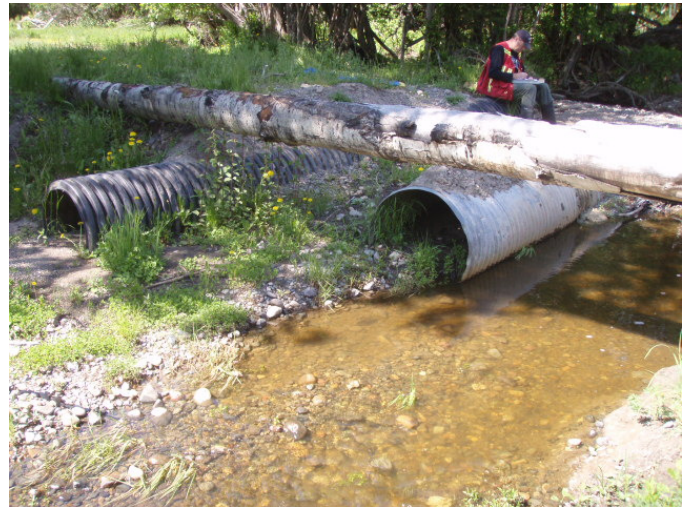
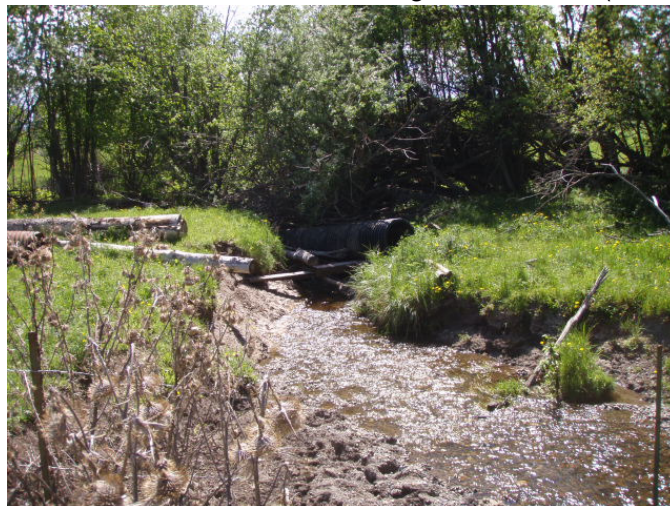
Date (mm/dd/yy)	6/7/2011		
Crossing ID #	Private CMP06		
Crew Name	OA/BF		
Stream Name	Shillestead Brook		
UTM	Easting	Northing	
10U	434599	5992137	
Road Name	Private access off of McLeod Rd		
Crossing Type	Round Culvert	Outlet Residual Pool (m)	NA
Embedded	NA	Inlet Drop	NA
Outlet Drop (cm)	NA	Fill Depth (m)	NA
Culvert Width (m)	0.6	Valley Fill	Deep Fill
Channel Width (m)	2.45	Habitat Value	Moderate
Stream Width Ratio (m)	4.08	Beaver Activity	No
Culvert Slope %	NA	Backwatered	NA
Stream Slope %	2	Fish Sighted?	No
Culvert Length (m)	6.3		
Fish Barrier Result			
Score	NA	Result	NA
Stream Priority Rank	1		
Recommendation			
These culverts are presently washed out and although in stream are not functioning. Landowners need to cross to get to fields. High priority culvert replacement.			
Comments			
This section of stream has a higher gradient, and its subdominant substrate consists of gravels which may be suitable for spawning. There are still willows and aspen present along the stream banks which offers shade and cover. However, cows are still permitted unfettered access to the stream which has caused erosion and sedimentation. The three culverts still present instream have been washed out and are no longer functioning. However, the landowner needs to have them replaced in order to access the field on the other side.

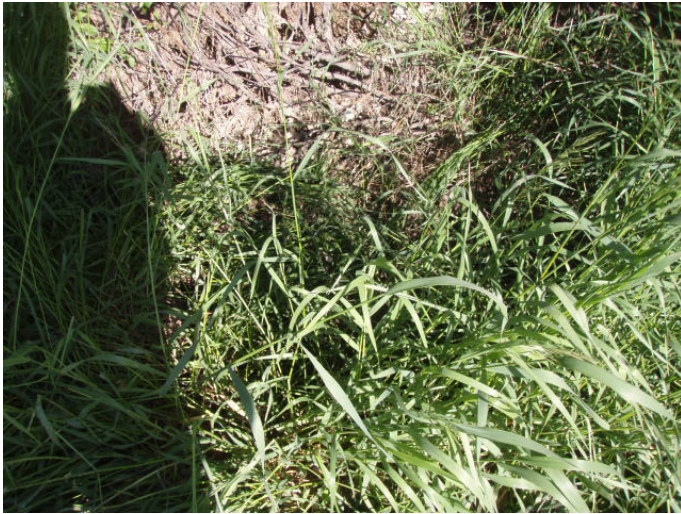
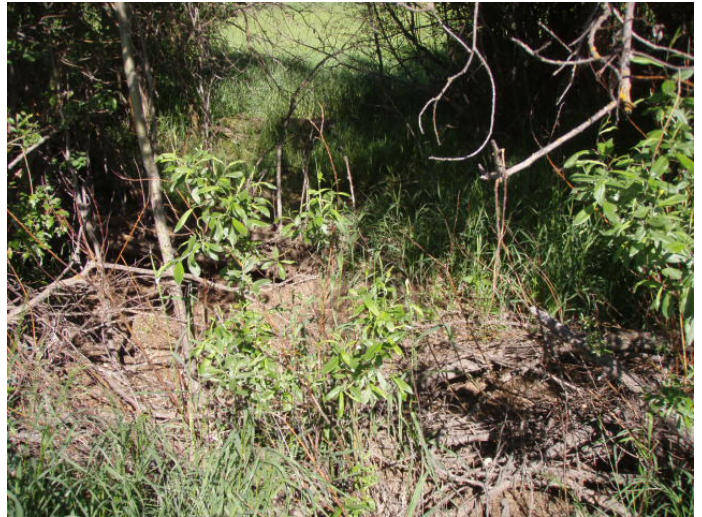
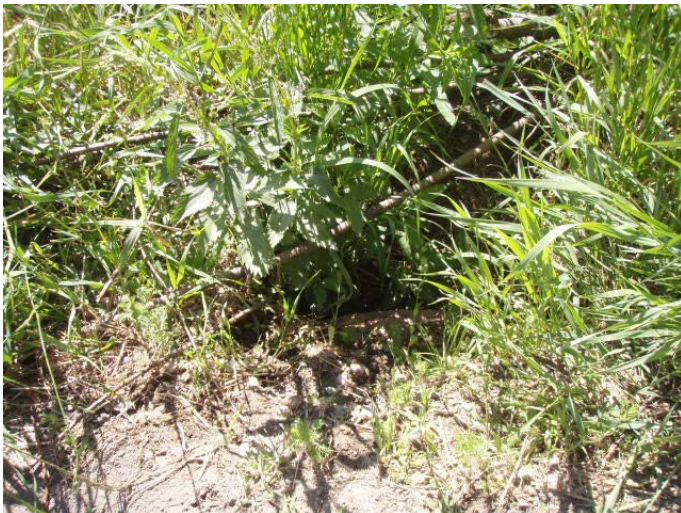
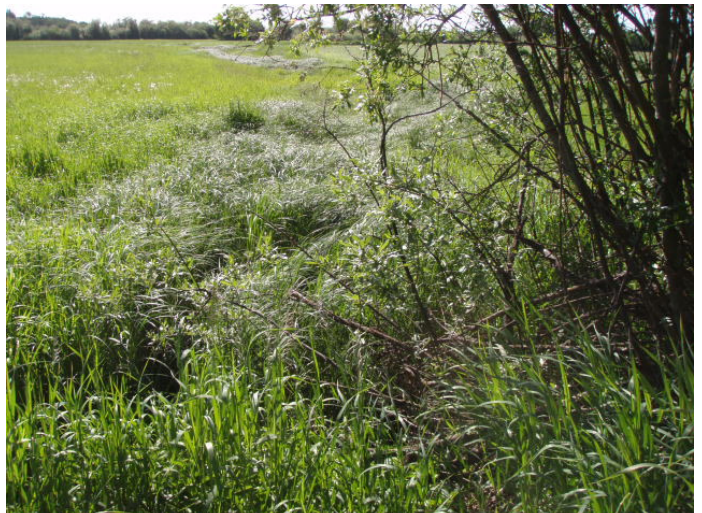
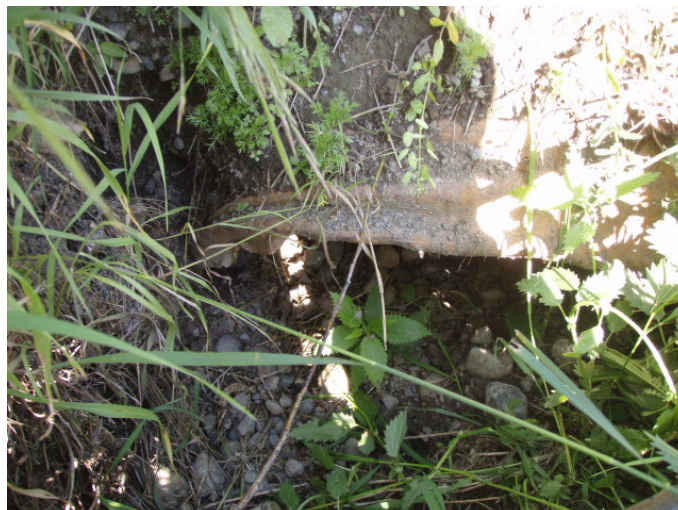
Date (mm/dd/yy)	6/21/2011		
Crossing ID #	Private CMP07		
Crew Name	OA		
Stream Name	Unnamed tributary to McIntosh Creek		
UTM	Easting	Northing	
10U	431730	5992237	
Road Name	Private Access off of McLeod Pit Rd		
Crossing Type	Round Culvert	Outlet Residual Pool (m)	0
Embedded	None	Inlet Drop	Yes
Outlet Drop (cm)	0	Fill Depth (m)	0.35
Culvert Width (m)	0.6	Valley Fill	Deep Fill
Channel Width (m)	1.39	Habitat Value	Low
Stream Width Ratio (m)	2.32	Beaver Activity	No
Culvert Slope %	1	Backwatered	0
Stream Slope %	1.2	Fish Sighted?	No
Culvert Length (m)	4.45		
Fish Barrier Result			
Score	18	Result	Potential Barrier
Stream Priority Rank	NA		
Recommendation			
Culvert is undersized; however, stream is more likely seasonal NCD. Currently totally dry. Low fish habitat value. Low to medium priority culvert replacement.			
Comments			
This drainage runs through hay field, there is no definable channel except on either side of the culvert. Although the culvert is undersized, it is not a high priority to replace this culvert based on habitat values.

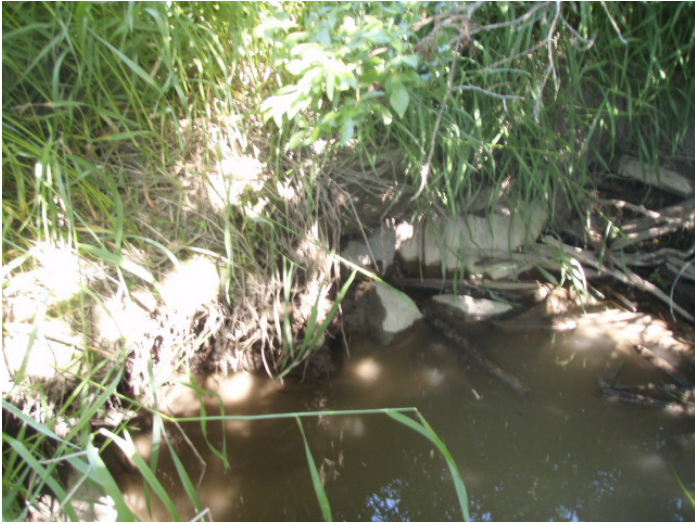
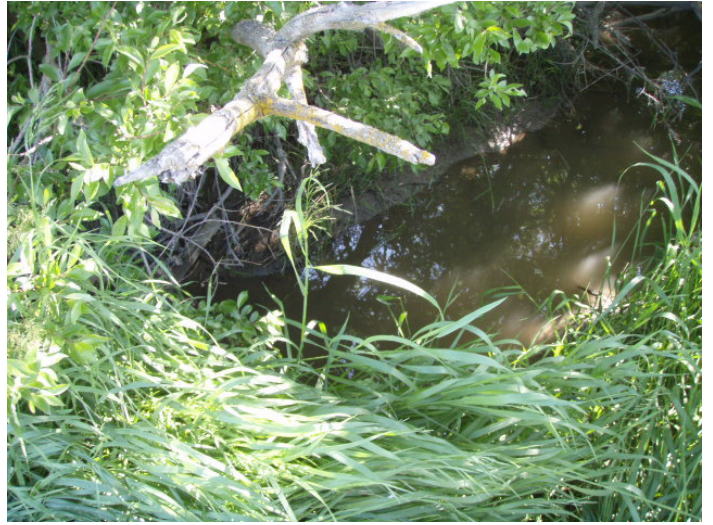
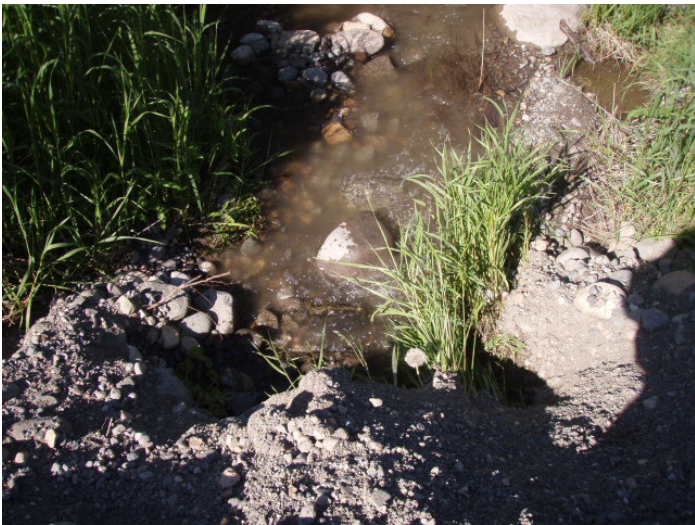
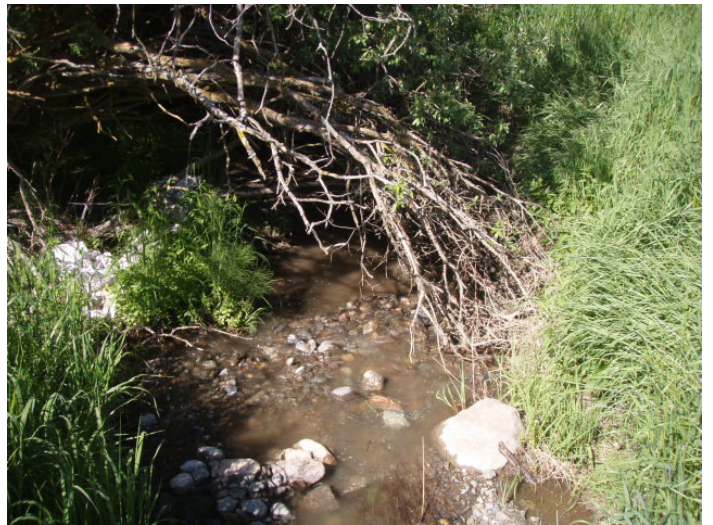
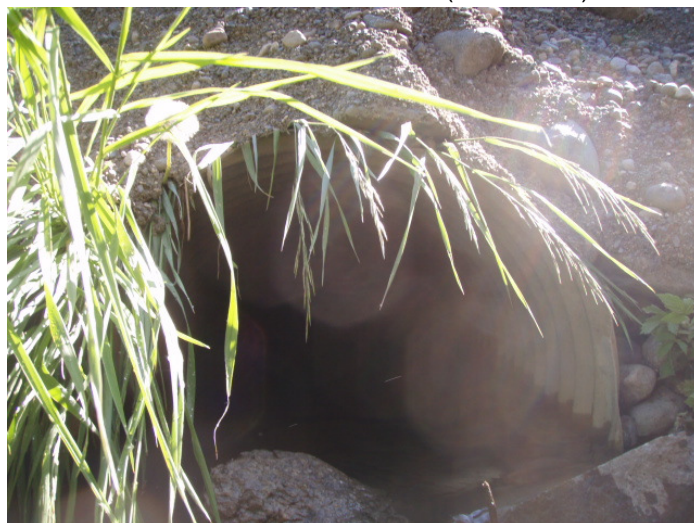
Date (mm/dd/yy)	6/21/2011		
Crossing ID #	Private CMP08		
Crew Name	OA		
Stream Name	McIntosh Creek		
UTM	Easting	Northing	
10U	432160	5992288	
Road Name	Private Access off of McLeod Pit Rd		
Crossing Type	Round Culvert	Outlet Residual Pool (m)	0.03
Embedded	None	Inlet Drop	No
Outlet Drop (cm)	8	Fill Depth (m)	0.57
Culvert Width (m)	0.63	Valley Fill	Deep Fill
Channel Width (m)	1.96	Habitat Value	Moderate
Stream Width Ratio (m)	3.11	Beaver Activity	No
Culvert Slope %	1.8	Backwatered	0
Stream Slope %	1.5	Fish Sighted?	No
Culvert Length (m)	5.95		
Fish Barrier Result			
Score	21	Result	Barrier
Stream Priority Rank	3		
Recommendation			
Culvert is a barrier. Stream is priority ranked as a 3, however the stream is considered moderate fish habitat. Medium to high culvert replacement priority.			
Comments			
The culvert is in need of replacement; it is undersized and is position incorrectly in the stream to one side. The stream has some spawning gravels, good willow cover, some deep pools and undercut banks.
